# PRE-SALE BUILDING INSPECTION REPORT

for The Estate of Mark Randell

3 Brandon Street  
Featherston, Wairarapa  
5710 New Zealand

Inspected by: Scott Topham | Inspection Date: 30 Oct 2025 | Ph: 0211199816

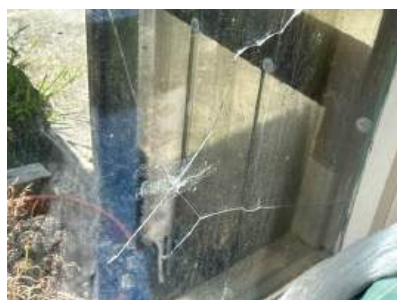
- Some of the windows were stiff to operate, this may be due to lack of use. Adjustment by a builder/joiner is recommended to allow the units to open and close freely. A cracked pane of glass was sighted to the lounge window, replacement of the affected pane is recommended by a glazing specialist.

#34: Broken window. Lounge northern wall.

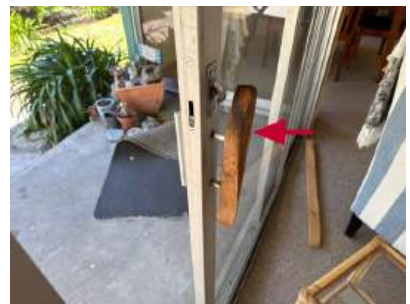
- The handles of the aluminium sliding doors were loose and missing, upgrades are recommended to ensure the doors can lock and operate correctly, the fixed pane of the lounge unit has also been temporarily secured in place, an aluminium joiner should be engaged to assess and determine a long term solution.

#37: temporary securing of fixed door sash

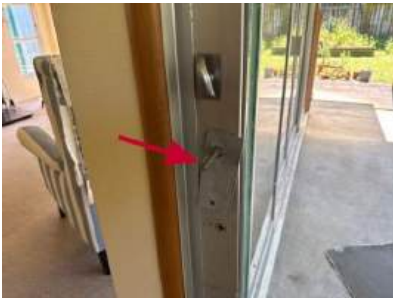
#38: lose handle lounge

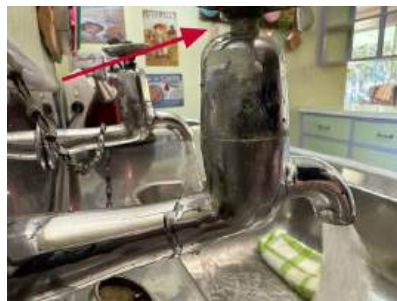
The water supply was operating correctly. The kitchen hot tap was leaking at the swivel while in use. Engage a licensed plumber for repairs.

#48: Hot water tap leaking when in use.

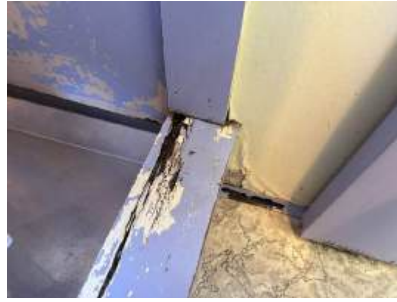
- Deterioration was detected to the shower unit. The unit does not appear watertight. Engage a plumber or shower installer now to replace this unit.

#69: timber decay to the shower step

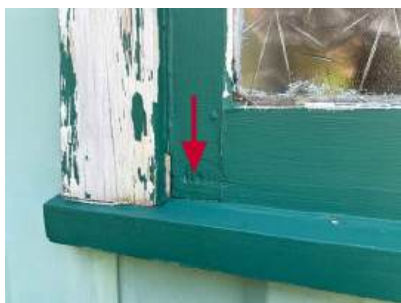
**Timber Joinery Details:** - General deterioration to the paint coating and glazing putty deterioration was sighted to some units. This can allow water to sit on the timber joinery, which could lead to rot. Repairs to the paint coating and glazing putty are required to help seal and protect the timber. A trade-qualified painter should be engaged to complete the work. Also; timber decay was detected in the windows photographed below. A licensed builder should be engaged to repair or replace the defective timber. Further decay could lead to potential water ingress in the wall cavity.

#104: Timber decay to toilet window.

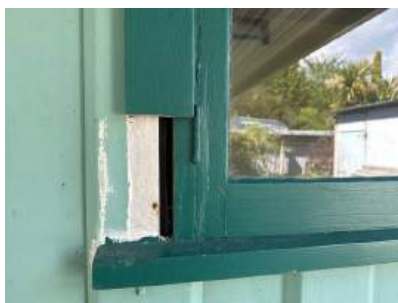
#105: Laundry window is missing part of the facing board

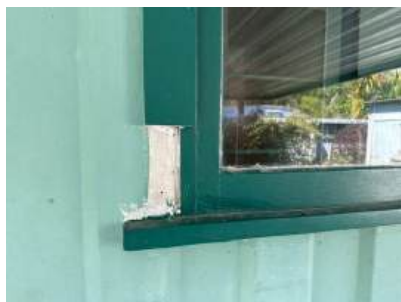
#106: Entrance window is missing part of the facing board.

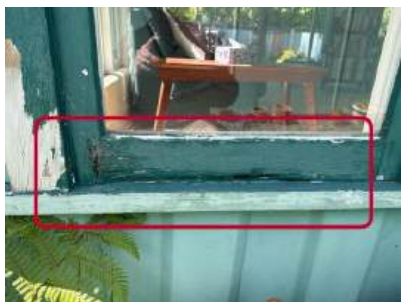
#107: Timber decay. Lounge western window.

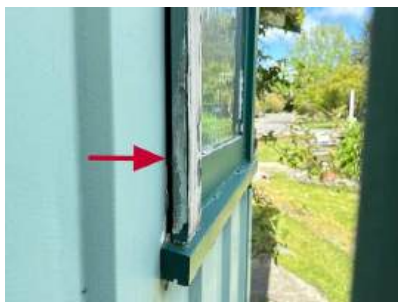
**Cladding Penetration Details:** - The steel framing members pass through the cladding and gaps were sighted. These are higher-risk design features that could potentially cause water ingress into the wall cavity. The penetrations require sealing around the perimeter to ensure they are watertight. A licensed builder should be engaged to complete the work. These areas should be regularly maintained and monitored.

#108: Gaps at cladding junctions

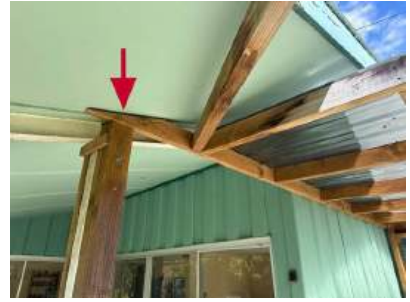
#113: improvement to the support at the end of the verandah is recommended.

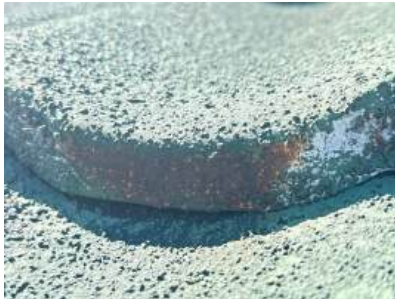
**- Roof** - Surface rust deterioration was occurring on the metal tiles and flashings. This appears to be due to the original roof coating deteriorating, exposing bare metal; further corrosion could lead to holes in the tiles/flashings. Loose tiles were also sighted where some of the nail fixings have lifted exposing the lap joints, this could lead to water ingress or uplift. A licensed roofer is required to assess the roof to determine the most appropriate repair and reconditioning approach.

#125: rust deterioration

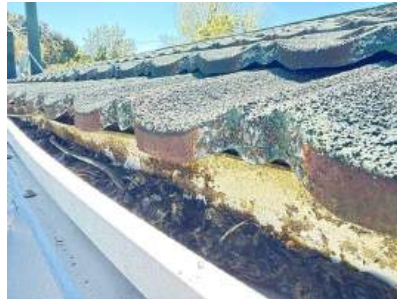
#126: rust deterioration

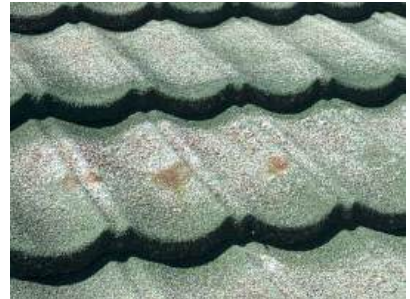
#127: rust deterioration

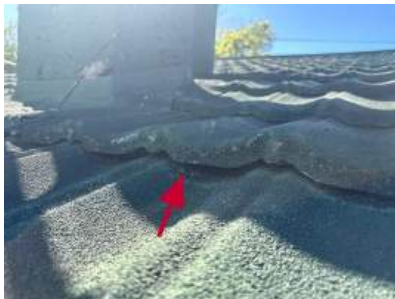
#128: lifted nail causing lap joints to be exposed

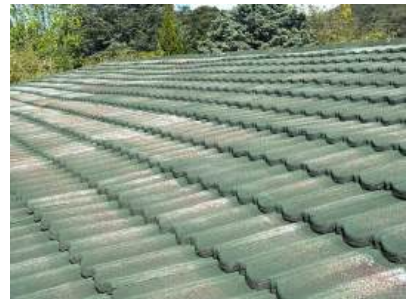
#130: coating deterioration

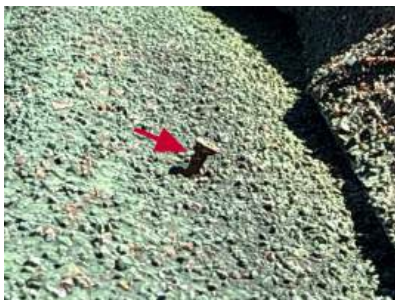
#131: lifted nail

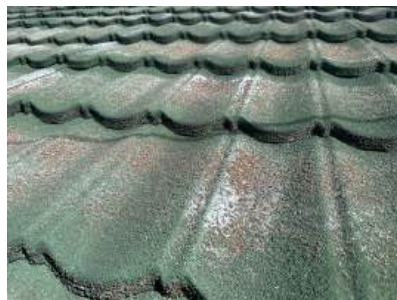
#132: coating deterioration

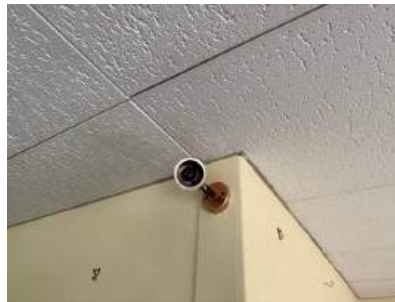
#184: missing light bulb in lounge

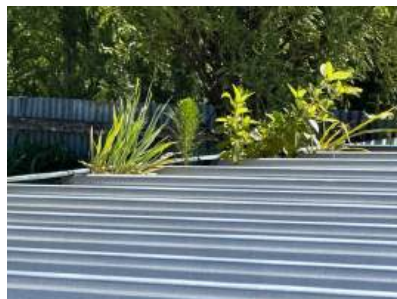
#238: vegetation in gutter, cleaning is recommended

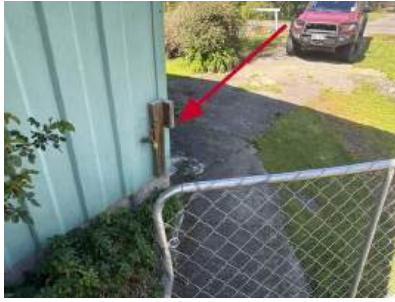
**Gate Details:** - The front gate has been directly fixed to the cladding. This is detailed as a risk area for potential water ingress to occur. A gap of at least 15mm is recommended at the cladding junction to help prevent deterioration and moisture ingress. A licensed builder is required to assess and determine the best repair solution.

#249: gate latch attached to cladding
