**Information request – CLM/2011/039099 - 21A Montclare Avenue, Ilam, Christchurch 8041.**

# EARTHQUAKE RECOVERY (EQR) DOCUMENTATION

## Statement of Claim Checklist / Repair Strategy

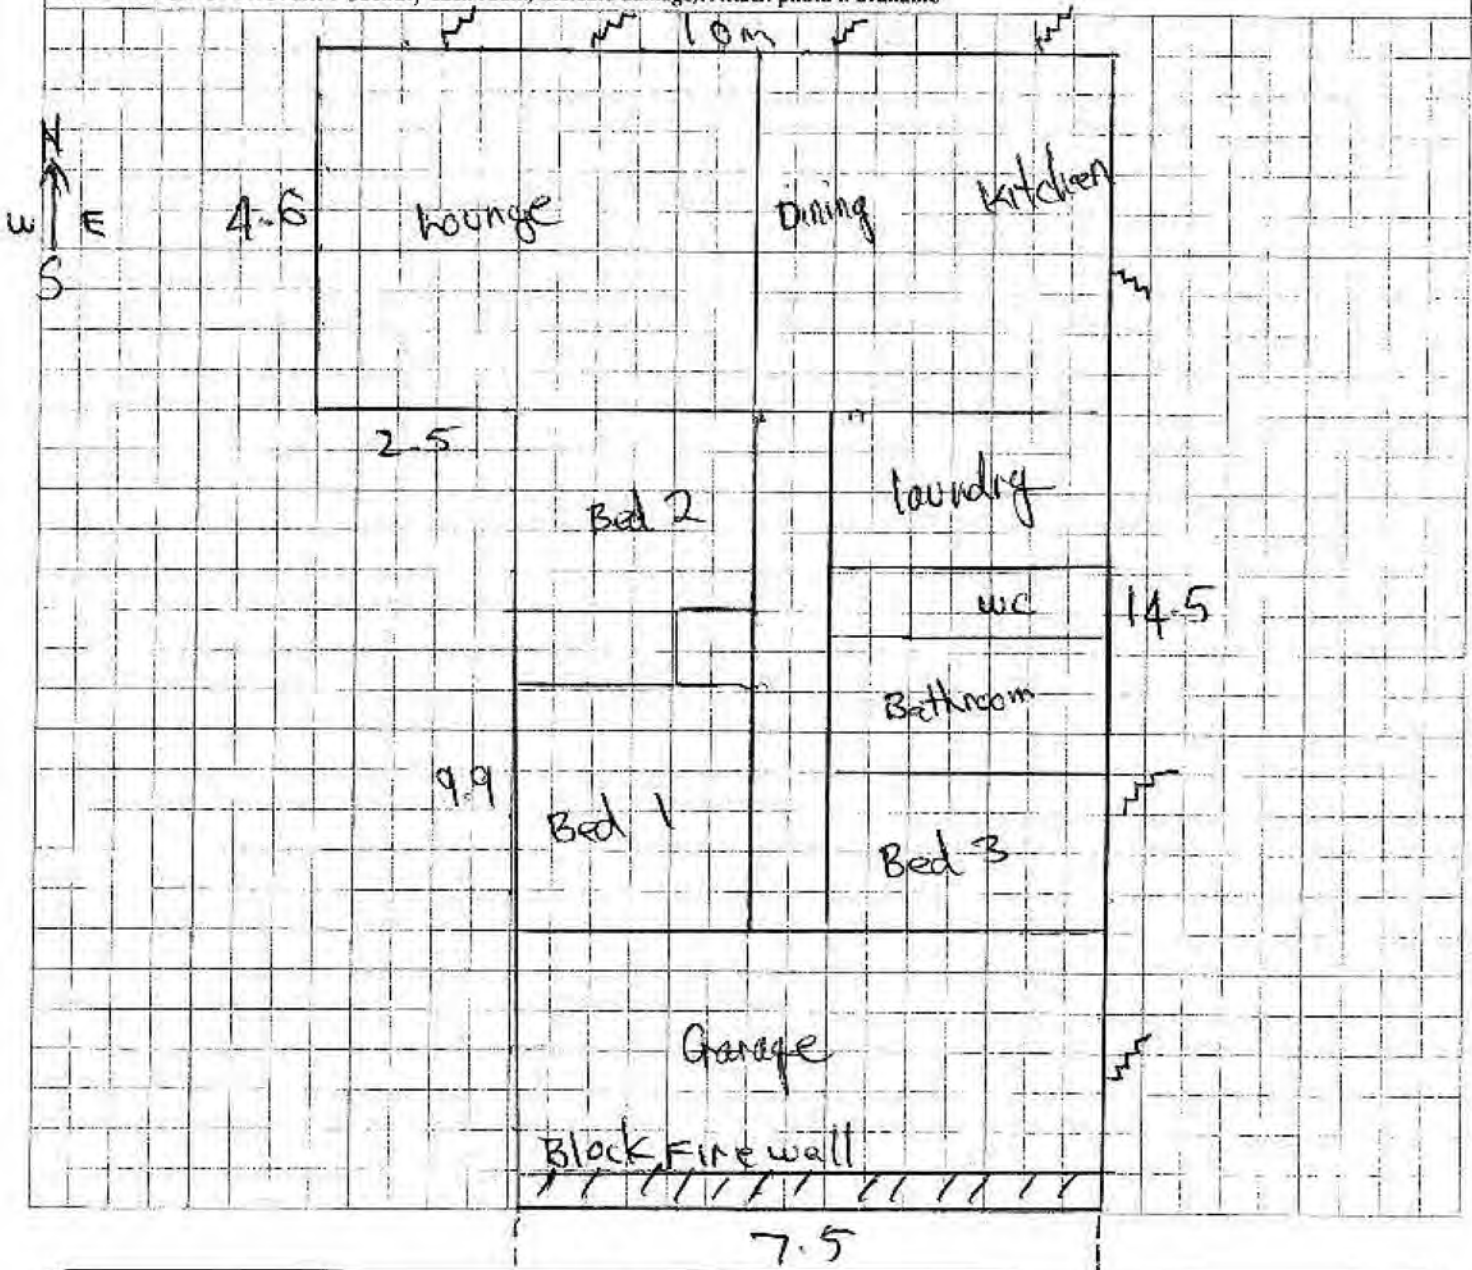
PLAN SKETCH OF PROPERTY (identify each room, indicate damage). Attach photo if available

6m  
5m  
crack between  
slab and footing

concrete crack

5 km step crack  
Handiflex 2.4x.6  
x 4.5  
labour 2 hrs
