# Christchurch Property Inspections Report

80 Tankerville Road,  
Hoon Hay

16/10/2025

## Pre-Sale Visual Non-Invasive Property Inspection

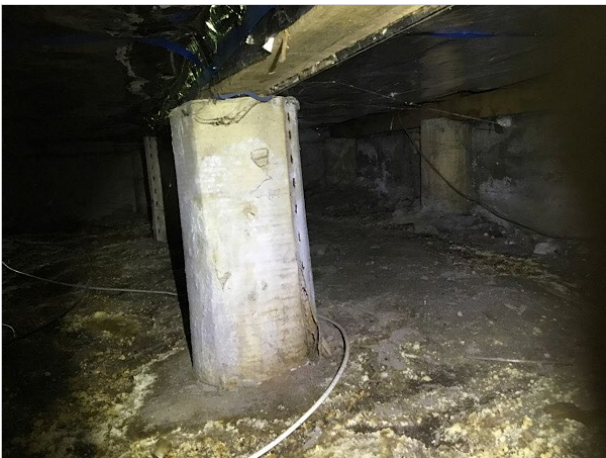
9. Typical pile and subfloor moisture barrier

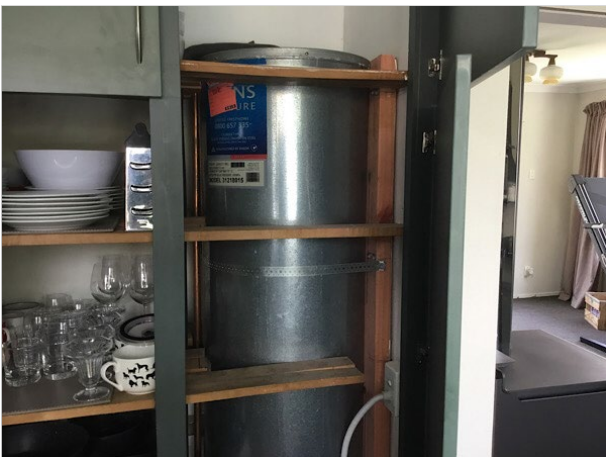
<b>Hot Water</b>	180L mains pressure electric hot water cylinder manufactured 2011 and located in the kitchen storage. Generally sound, typical for age. Untested. Seismic strapping is installed.	Photo 11
<b>Electrical Services</b>	A mixture of original fuses and mini circuit breakers on switchboard. (See switchboard photo) Power was on at time of inspection. Untested.	12
<b>Plumbing Services</b>	Some polybutylene pipework visible. No Dux Qest plumbing observed.	
<b>Ventilation System</b>	HRV. Control panel in hallway.	
<b>Smoke Alarms</b>	Installed within 3m of all bedrooms. Untested.	
<b>Intruder Alarms</b>	N/A.

11. 180L mains pressure HWC manufactured 2011

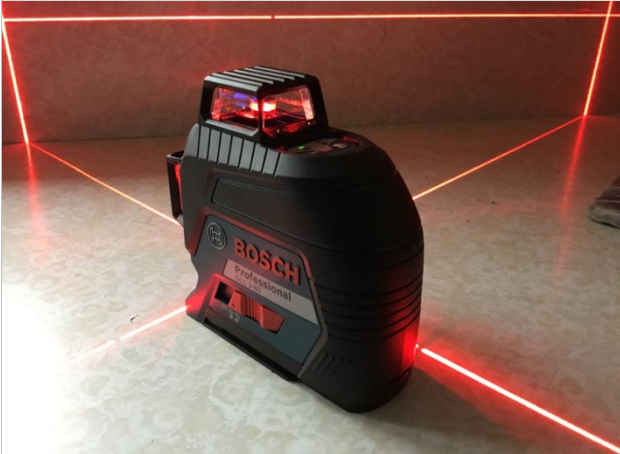
13. Floor levels checked with laser level

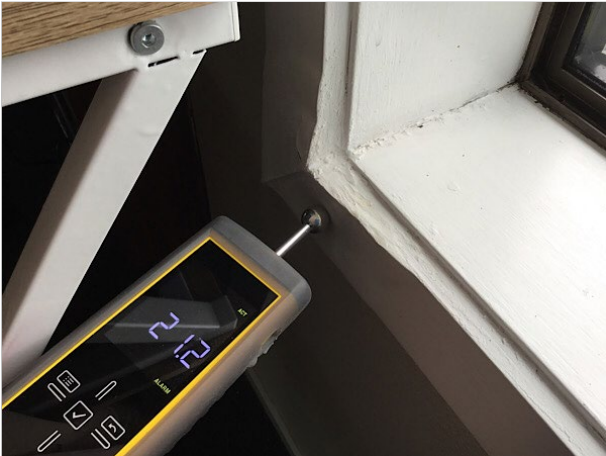
Windows/ Slider	Aluminium double glazed. Operational. Generally sound, typical for age.  Swollen window architrave.	Photo  19
Flooring	Carpet. Appears in good condition, typical for age.	
Walls	Painted lining paper and grooved panel. Generally sound, typical for age.	
Ceilings	Painted plasterboard. Generally sound, typical for age.	
Lighting	Fixed. Operational. Generally sound, typical for age.	
Architrave/ Skirting	Paint finish. Generally sound, typical for age.	
Heating	N/A.	
Moisture Levels	Tested low at time of inspection.

19. Low moisture on swollen architraves

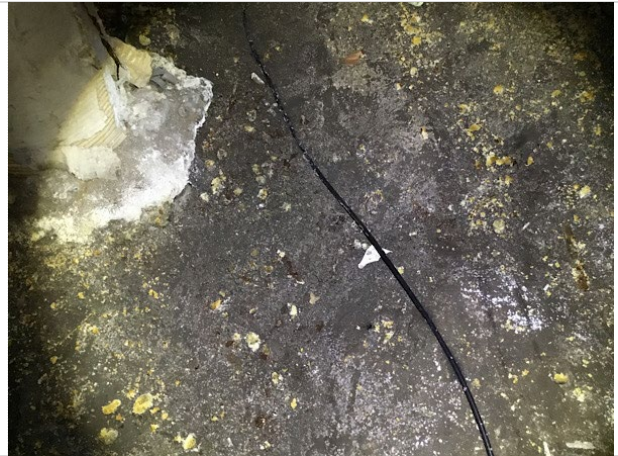
20. Damp ground under house

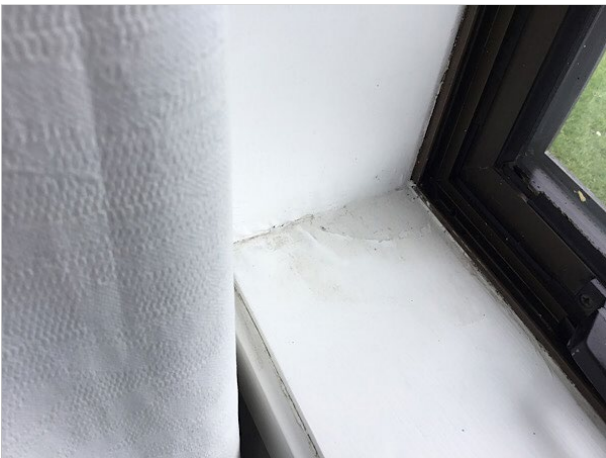
21. An example of unfinished reveal repairs

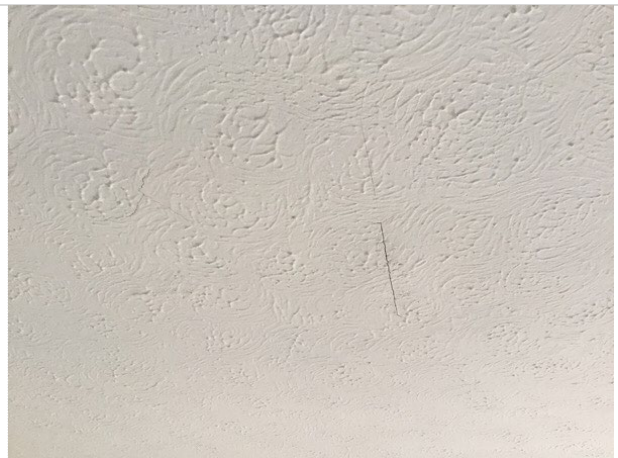
Flooring	Carpet. Appears in good condition, typical for age.	Photo
Walls	Painted plasterboard. Generally sound, typical for age.	
Ceiling	Painted stipple. Generally sound, typical for age.  Hairline crack along sheet join.	22
Lighting	Fixed. Operational. Generally sound, typical for age.	
Doors	Paint finish. Operational. Generally sound, typical for age.	
Windows	Aluminium double glazed. Operational. Generally sound, typical for age.  Moisture damage reveal, repair needs finishing.	21
Wardrobe	Double slider. Built in. Operational. Generally sound, typical for age.	
Architrave/ Skirting	Paint finish. Generally sound, typical for age.	
Heating	N/A.	
Moisture Levels	Tested low at time of inspection.

22. Cosmetic ceiling crack in bedroom 1

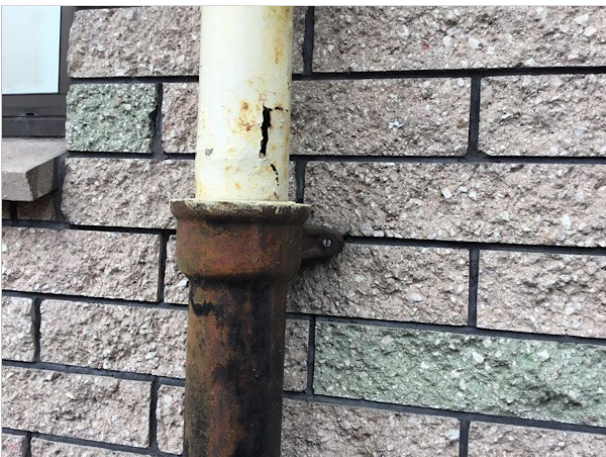
23. Sewer vent pipe corroded

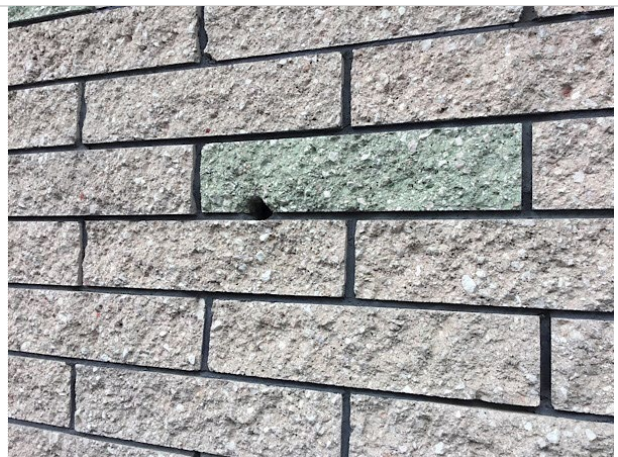
24. Hole from old toilet overflow pipe should be sealed

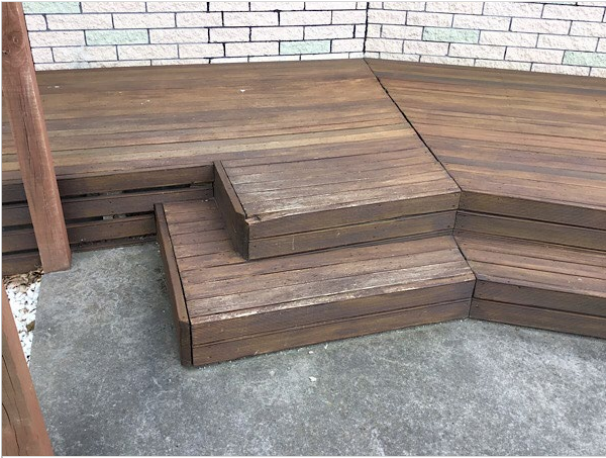
Site	Flat urban site with street frontage to the east.	Photo
Dwelling	This is a single-storey 3-bedroom, 1 bathroom home. Summerhill stone veneer over timber frame, timber subfloor sitting on vented concrete ring foundation. Painted corrugated steel roofing.	
Garage	Detached double with covered deck attached.	
Driveway	Concrete. In sound usable condition for age.	
Garden	Established trees and shrubs.  Note: It is important with this type of cladding to keep gardens clear from the base of the wall cladding.	
Lawn	Established grass.	
Letterbox	Generally in sound condition for age.	
Boundary Fence	Fences on all boundaries. Generally in sound condition for age.	
Paths/Patios/Decks	Concrete paths to front and back doors. Generally in sound condition for age.  Deck due for recoating.

25. Deck due for recoating

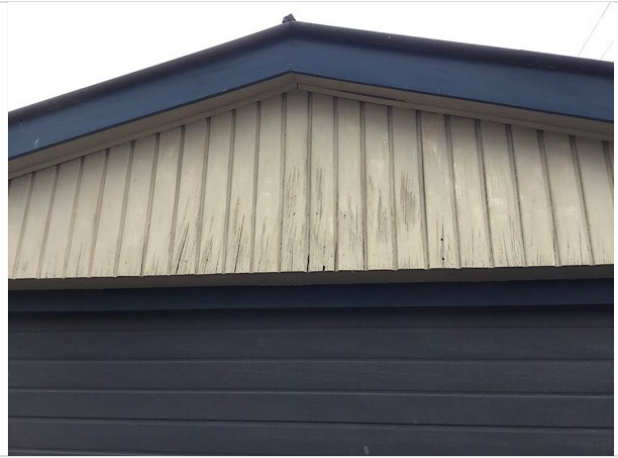
Flooring	Concrete and loose laid vinyl.	Photo
Walls	Concrete block. Generally sound, typical for age.	
Cladding	Concrete block and timber gable end. Generally sound, typical for age.	26
Ceiling	Unlined, timber frame. Generally sound, typical for age.	
Roof	<p>Painted corrugate with lead head nail fixings. Generally sound, typical for age.</p> <p>This type of fixing will need to be occasionally checked for general maintenance purposes.</p> <p>Note: Lead head nails are old and no longer perform well, these may require replacement in the future.</p>	
Guttering	PVC. Generally sound, typical for age.	
Downpipes	PVC. Generally sound, typical for age.	
Side Door	Aluminium single glazed. Operational. Generally sound, typical for age.	
Windows	Aluminium and steel single glazed. Operational. Generally sound, typical for age.	
Garage Door	Coloured steel, sectional, auto opener. Generally sound, typical for age.

26. Garage gable end due for painting
