PROPERTY CHECK EXPRESS PLUS WEATHERTIGHTNESS REPORT

Job Number	54387
Client	Giacomina King
Property Inspected	29 Saracen Avenue, Northwood, Christchurch
Inspection Date	13 April 2026
Building Surveyor	Darin Devanny
NZIBS Registration Number	BSI0100
Weather Conditions	Overcast
Scope of Report	Visual inspection of the buildings that are listed in this report for the purpose of a residential inspection in accordance with NZS4306: Residential Property Inspections.
Report Ordered By	Giacomina King - Vendor
Orientation	For the purpose of this report, the main entrance to the house is on the west elevation.

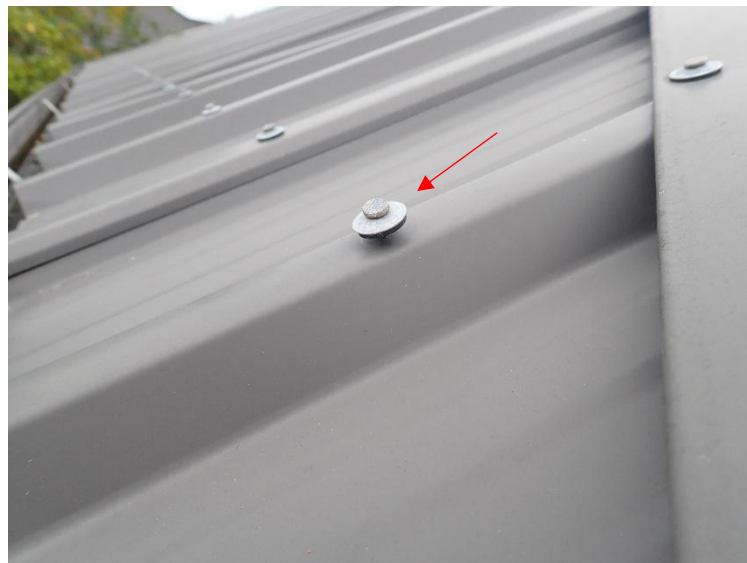
There are several proud nails on the western, northern, and eastern elevations. It is recommended that these are replaced by roof screws or correct fixings to prevent water from entering the gaps and into the roof space.

The valley gutters on the outer roof to the western and northern elevations require clearance as part of routine maintenance to allow free flow of water to the spouting.

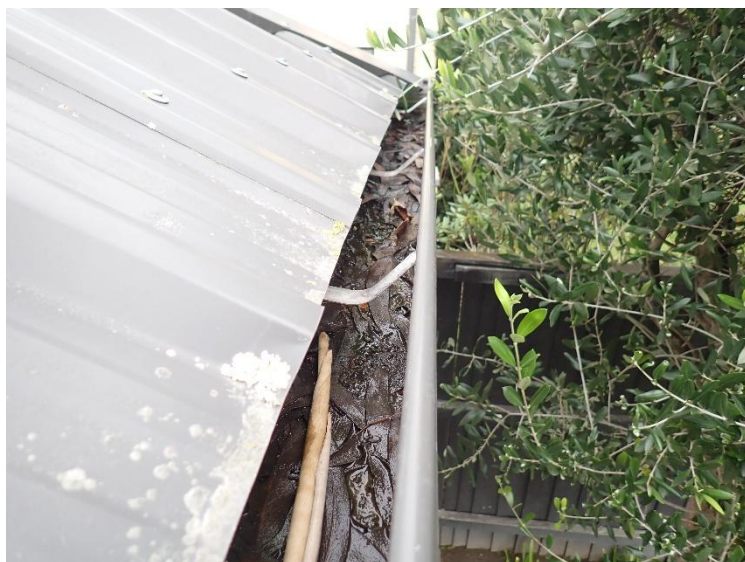
There are areas of organic debris build-up in the spouting. This should be cleared as part of routine maintenance to allow the free flow of water to the downpipes.

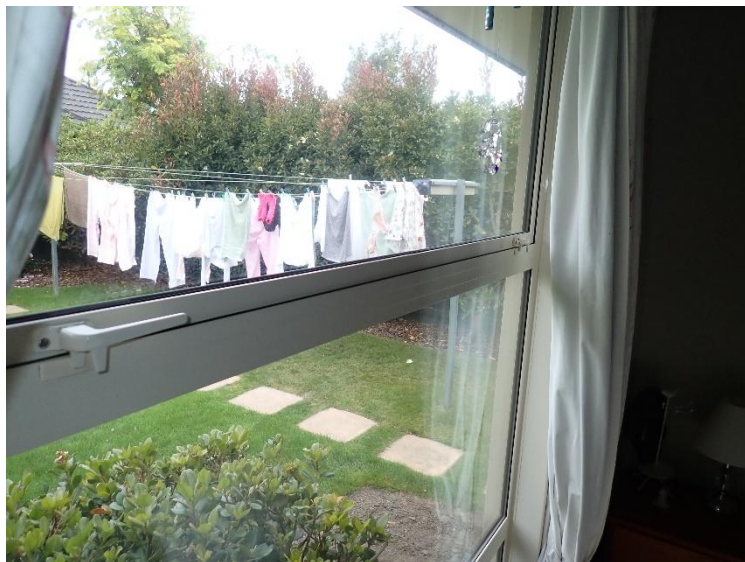
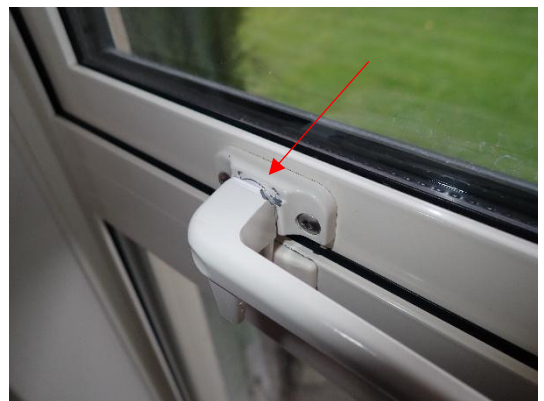
There is damage to the window locks. This does not affect the function of the window however replacement could be considered.

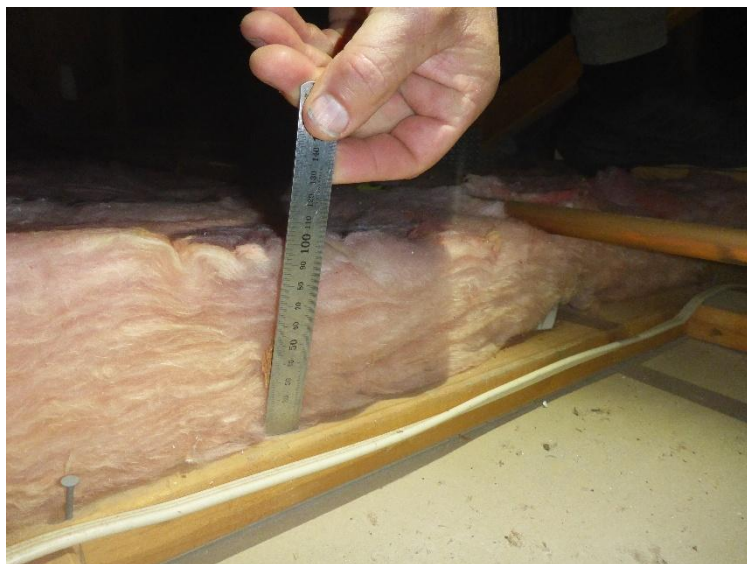
The ceiling insulation does not meet Healthy Homes standards. Improvements could be considered.
