Scope of Works

Assessment of Property at 6 JELLICOE STREET, SOUTH NEW BRIGHTON, CHRISTCHURCH 8062 on 19/09/2011

Address	6 JELlicoe STREET, SOUTH NEW BRIGHTON, CHRISTCHURCH, 8062	EQC Claim Number	CLM/2011/101565
Hazards	None evident	EQC Assessor (L,F)	Bublitz, Dave
Inspection Date	19-Sep-2011	Placard	No Sticker
		EQC Estimator (L,F)	Richards, Brad

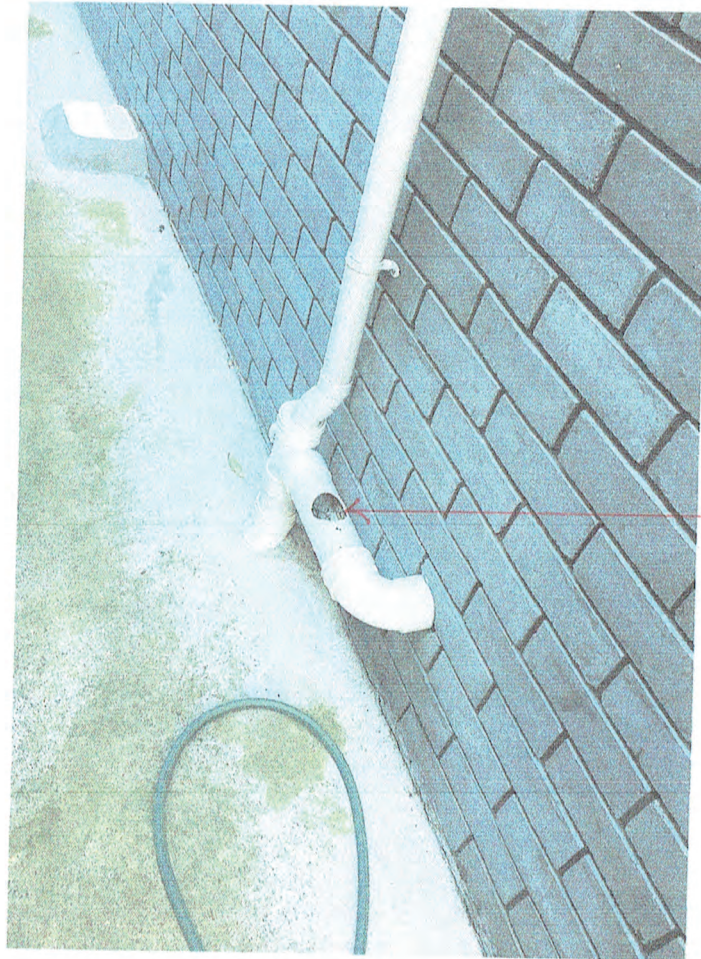
6 JESSIE ST
Sewer

The drains are all PVC. The contractor opened the P Pan toilet for access and attempted to camera survey the sewer drain from this access, unfortunately the nearby square junction would not allow the camera to access the remainder of the drain. The sewer drain is a separate line that runs through a neighbouring property and it was difficult to arrange any other access point. As the storm water drain incurred no damage and there have been no issues with the sewer it has been classed as having no earthquake damage.

CAMERA WOULD NOT
GET AROUND SQUARE JOINT

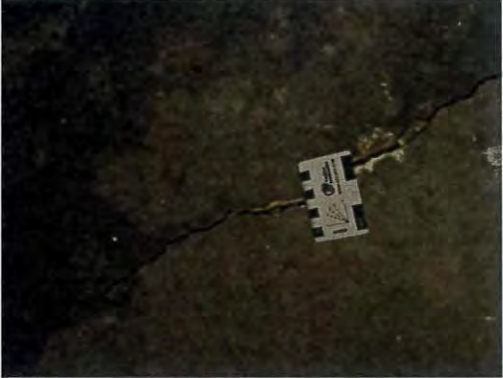
Number	Photo	Comment
1

Cupboard floor crack
2

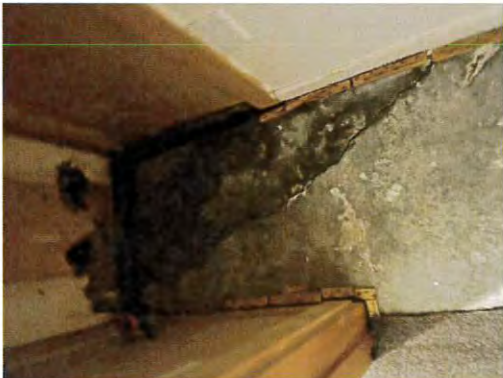
Cupboard floor crack
3

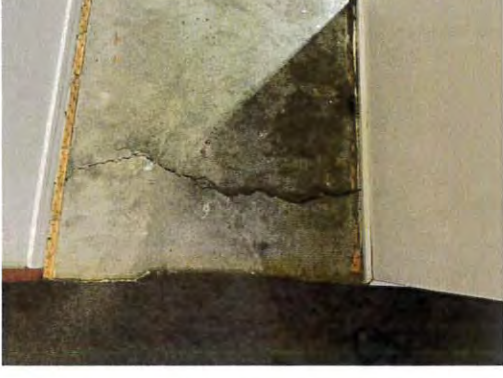
Hallway floor crack
4

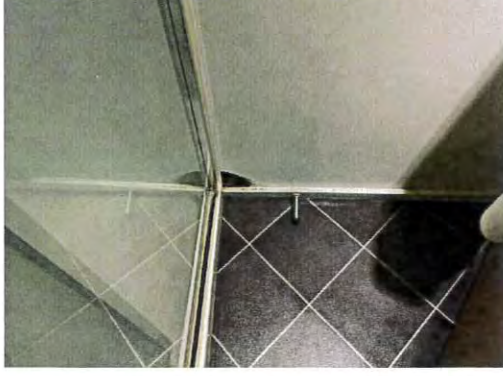
Wall decay in bathroom

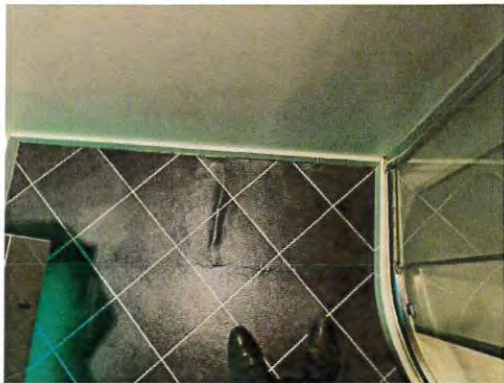
Number	Photo	Comment
5

Floor cracks in bathroom mirrored in vinyl
6

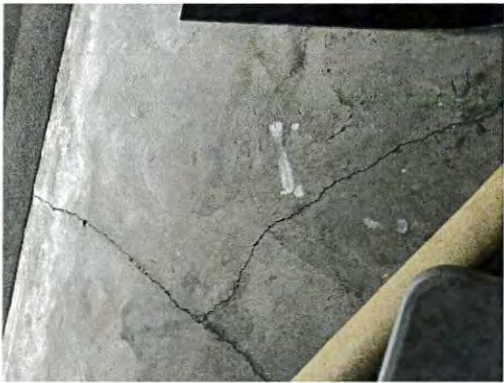
Garage floor cracks previous claim as per EQ
7

As requested, here is a fixed price quote for the crack repair to the garage slab at 6 Jellicoe Street. The cracking will be opened up, filled with epoxy untill full and then left flat with a grinder. The process will take three consecutive days to be confirmed by owner/appropriate person.

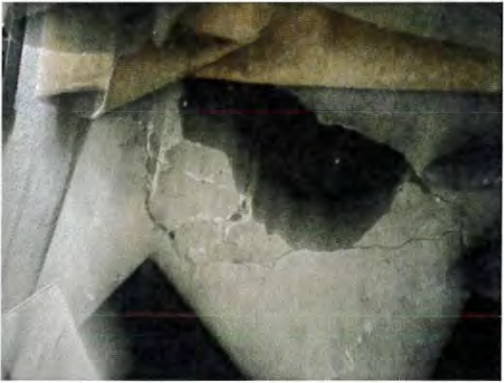
Additional damage to the garage concrete slab

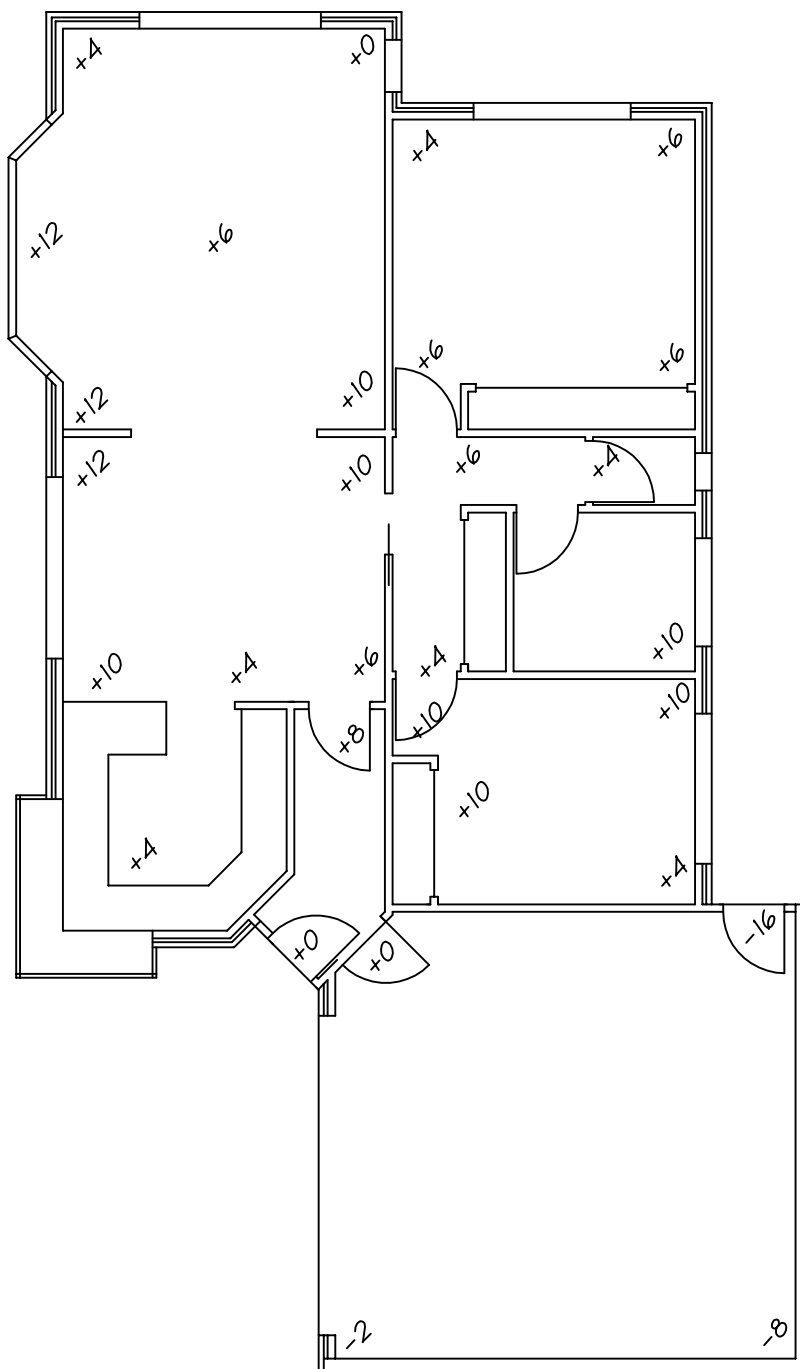
* Indicates existing house floor levels recorded on 21.05.2021.

Floor levels are within MBIE tolerances for the Canterbury Earthquakes.
No floor leveling will be required.
