## RESIDENTIAL HOUSE INSPECTION

69 Bower Ave  
Christchurch, Canterbury Region 8083

06/11/2025

Kiwi House Inspections

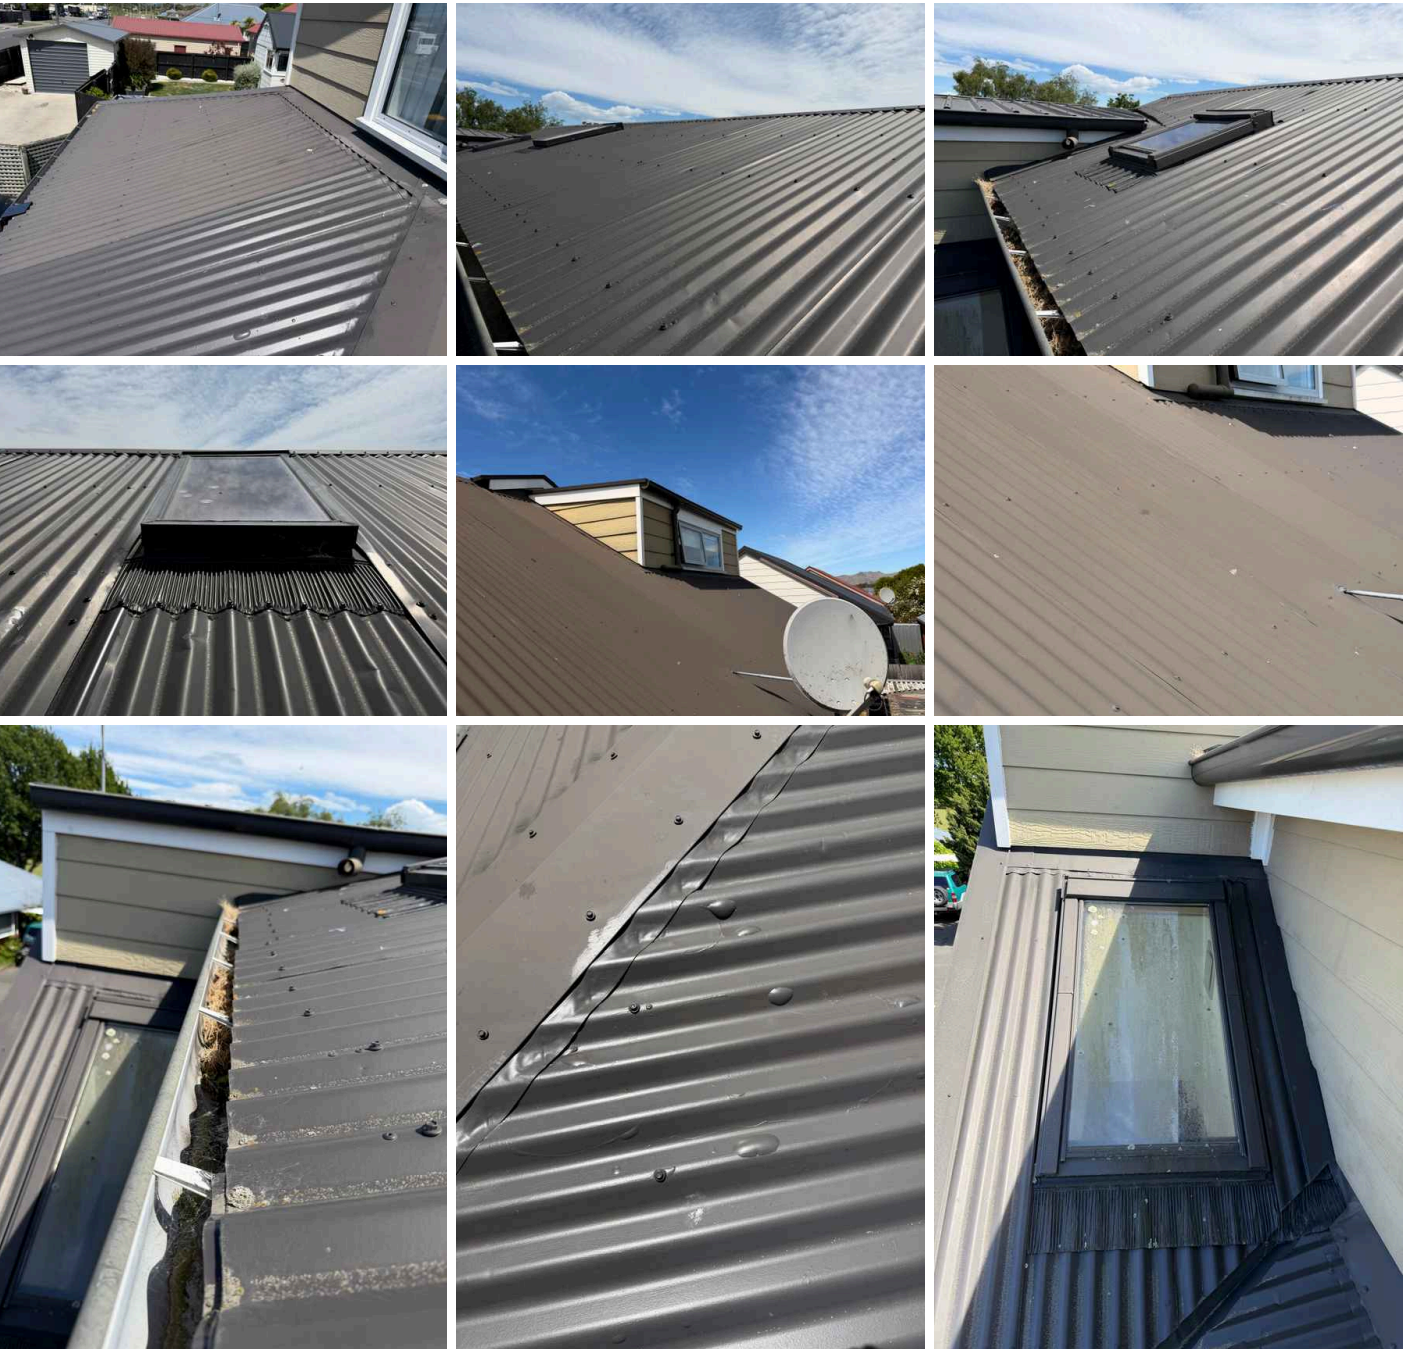
Blistering of the roofs paint system has been observed.

Roof paint bubbles are primarily caused by moisture trapped behind the paint layer, which can come from roof leaks, high humidity, or poor surface preparation. Other factors include improper application, environmental heat, and using low-quality materials. Essentially, when moisture or air gets trapped, it expands due to heat and pushes the paint away from the surface

Regular cleaning and preventative maintenance will prolong the longevity of the roof system. [More information can be found by clicking here.](#)

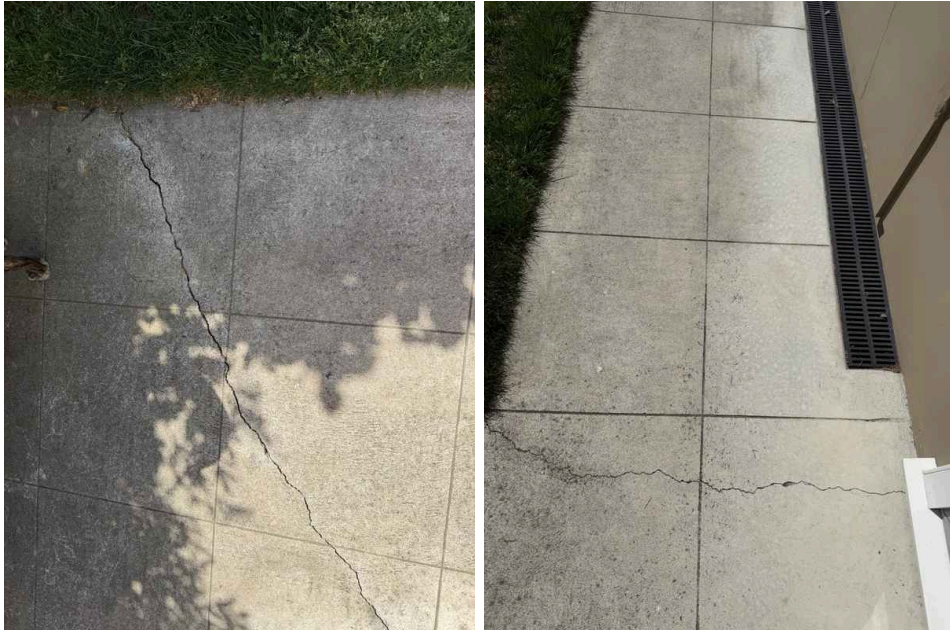
## 10.2.1 Paths

**CRACKING TO THE CONCRETE SURFACES NOTED**

This is consistent with the age of the concreted surfaces and era of construction.

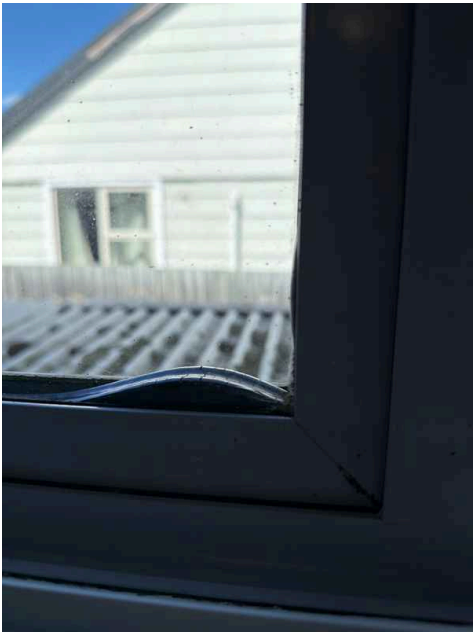
23.2.1 Exterior Joinery  
**SPACER BAR HAS MOVED**  
Unit is sound

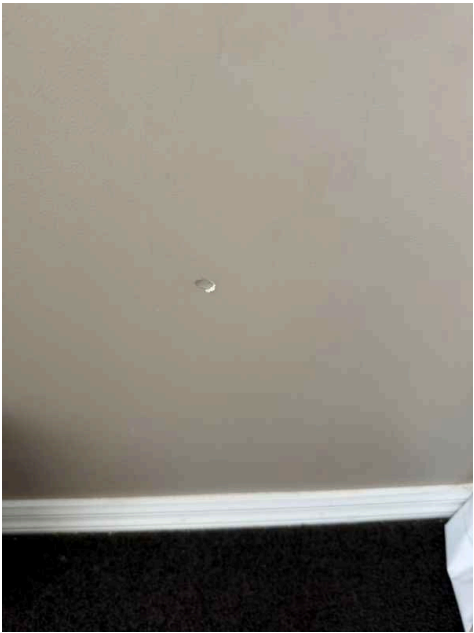
24.1.1 Internal Linings

**WEAR & TEAR TO WALLS NOTED**

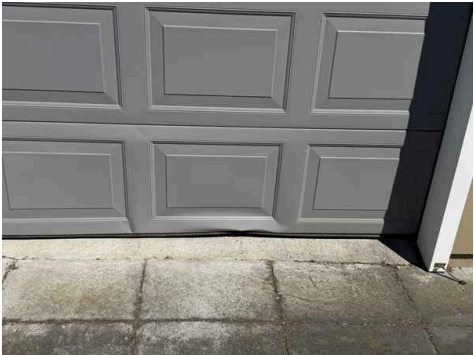
28.4.1 Garage Door  
**IMPACT DAMAGE IS NOTED**  
impact damage to the damage door is visible.
