EQC Full Assessment Report

Claim Number: CLM/2011/022688
Claimant: A OBRECHT
Property Address: 69 BOWER AVENUE
 NEW BRIGHTON
 CHRISTCHURCH 8083

Assessment Date: 28/07/2011 17:40
Assessor: Halligan, Steve
Estimator: Eady, Chris
Property Occupied By: Owner Occupied

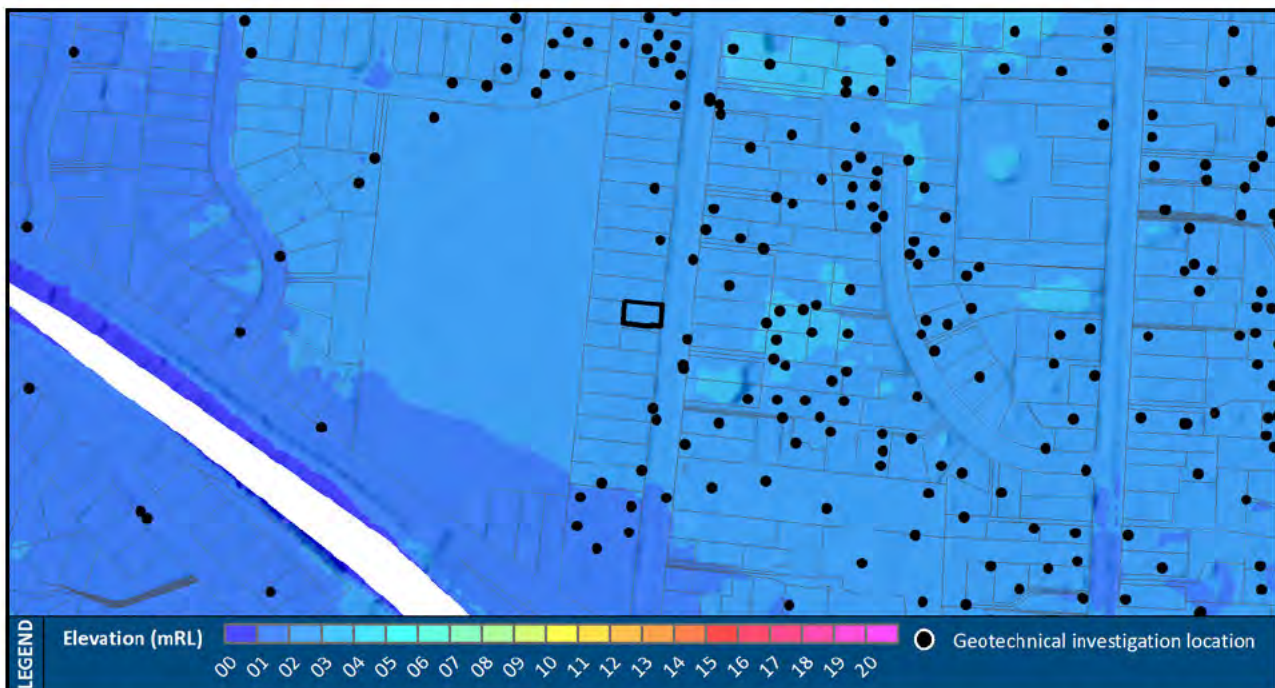
Map 1: Post Canterbury earthquake sequence ground surface elevation and geotechnical investigation locations

This map shows the ground surface elevation (i.e. the height of the land) following the Canterbury earthquake sequence. The elevation shown is the height above mean sea level.

The black dots show the locations of geotechnical investigations. These comprise a combination of Cone Penetration Tests (CPTs), boreholes and laboratory tests.

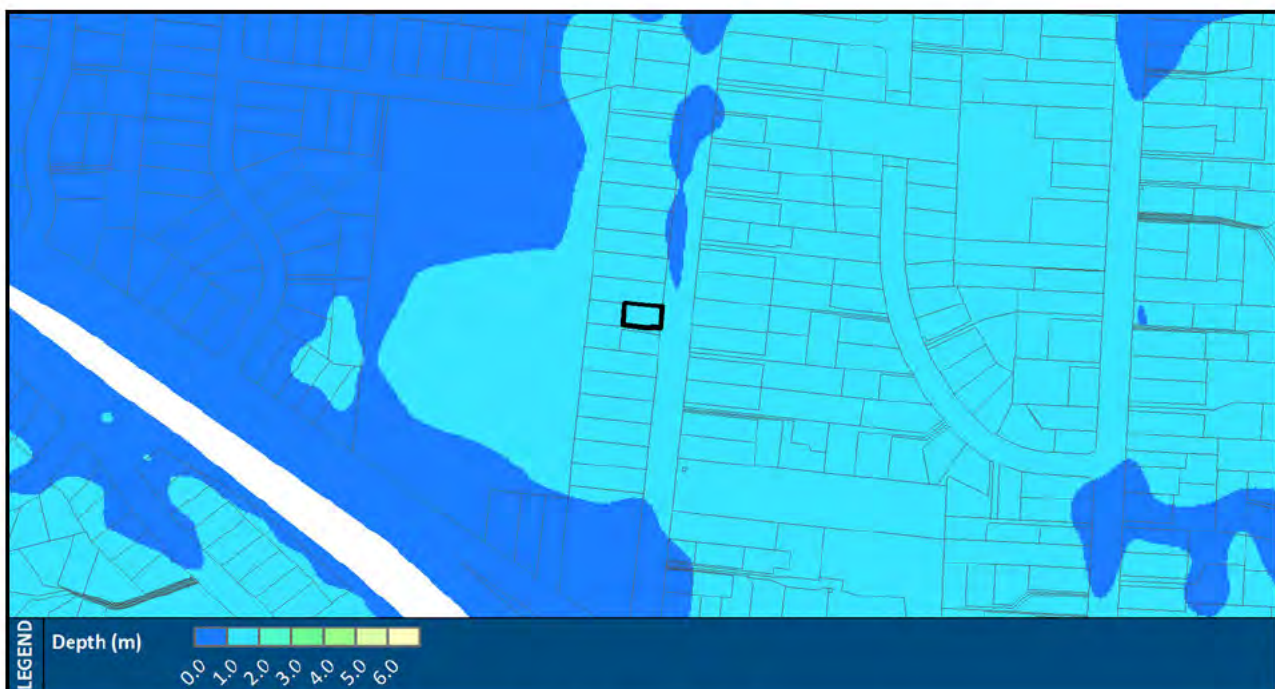
Map 2: Post Canterbury earthquake sequence depth to groundwater

This map shows the median depth to groundwater below the ground surface after the Canterbury earthquake sequence.

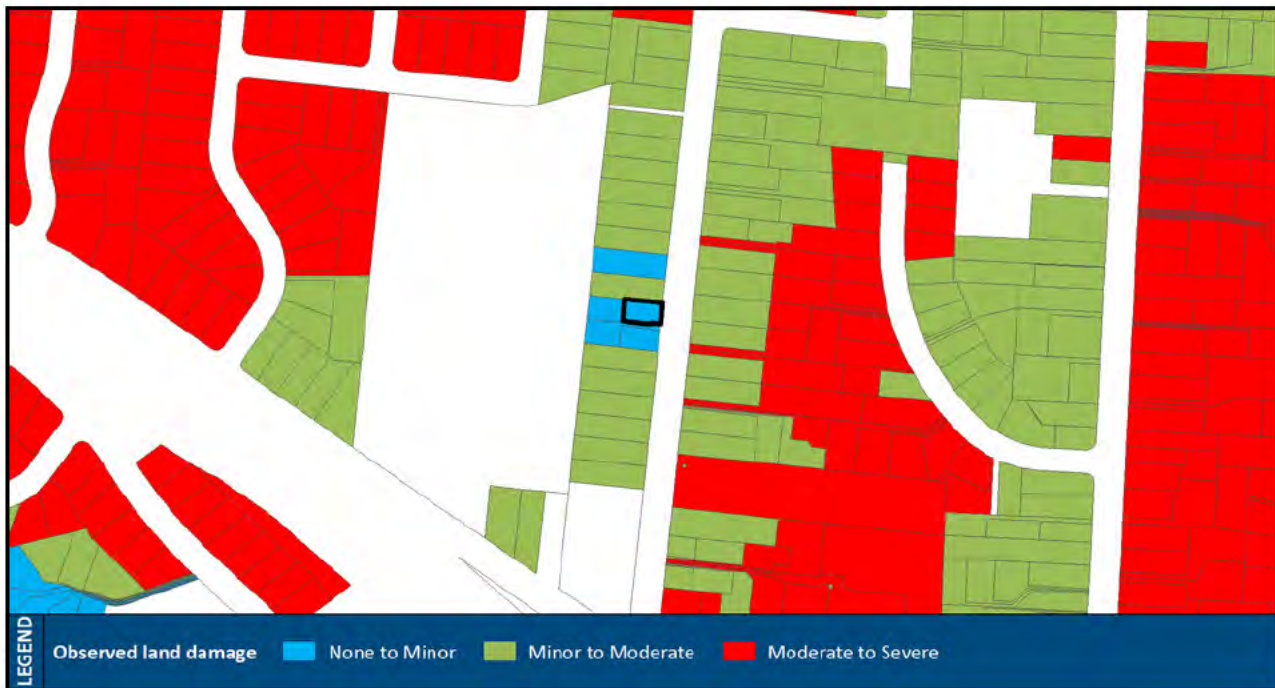
Map 3: Worst observed land damage due to the Canterbury earthquake sequence

This map shows the worst observed land damage recorded for the four main earthquakes during the Canterbury earthquake sequence. Descriptions of the observed land damage categories are: **None to Minor** – no observed liquefaction related land damage through to minor observed ground cracking but with no observed ejected liquefied material at the ground surface; **Minor to Moderate** – observed ground surface undulation and minor-to-moderate quantities of observed ejected liquefied material at the ground surface but with no observed lateral spreading; and **Moderate to Severe** – large quantities of observed ejected liquefied material at the ground surface and severe ground surface undulation and/or moderate-to-severe lateral spreading.

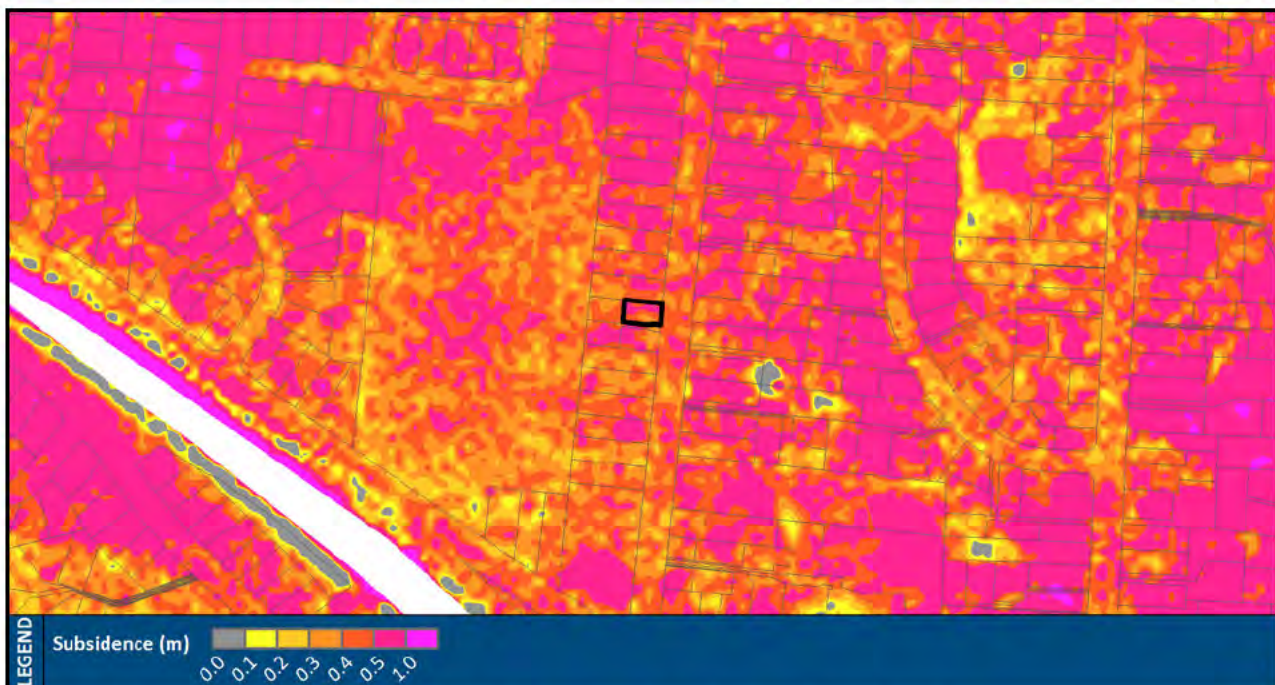
Map 4: Total ground surface subsidence due to the Canterbury earthquake sequence

This map shows the estimated total amount of ground subsidence as a result of the Canterbury earthquake sequence. Ground surface subsidence is estimated by comparing ground surface levels after each of the four main earthquakes. Adjustments have been made to the map to remove subsidence or uplift that is not as a result of the Canterbury earthquake sequence (e.g. man-made activities such as earthworks).
