# PRE-SALE BUILDING INSPECTION REPORT

for The Estate of Mark Randell

3 Brandon Street  
Featherston, Wairarapa  
5710 New Zealand

Inspected by: Scott Topham | Inspection Date: 30 Oct 2025 | Ph: 0211199816

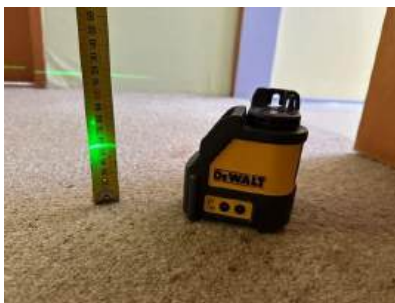
#23: 55mm

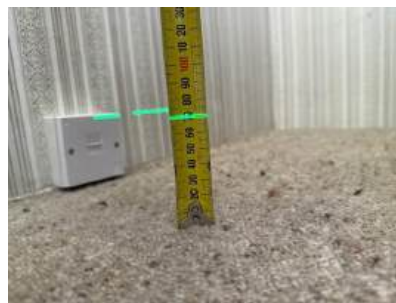
#24: 70mm

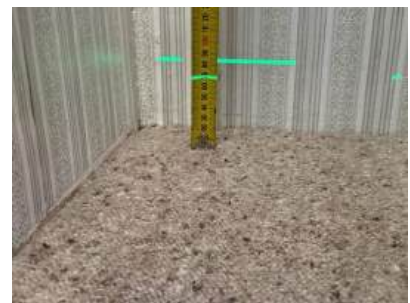
#25: 70mm

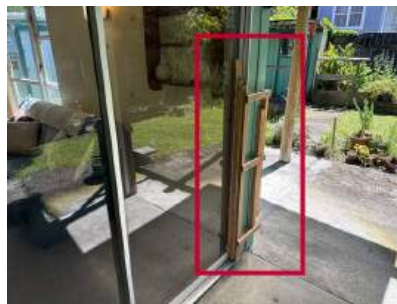
#37: temporary securing of fixed door sash

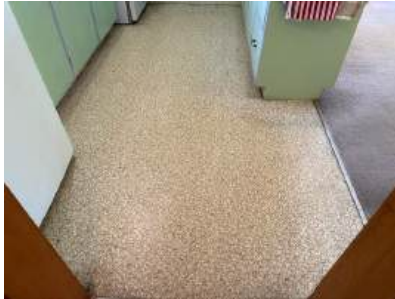
#50

- Due to the age of the dwelling, the vinyl or the backing of the vinyl used for the floor coverings could contain asbestos, this is unknown without lab testing. CheckHome recommends keeping the product sealed and not disturbing, we recommend testing prior to any remedial works taking place.

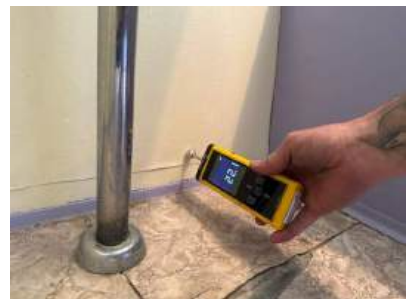
#58: Acceptable reading

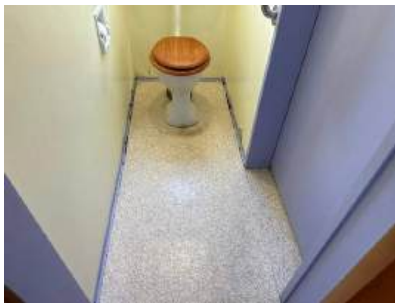
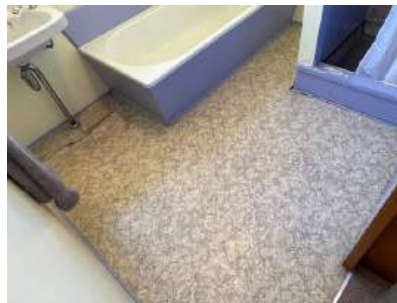
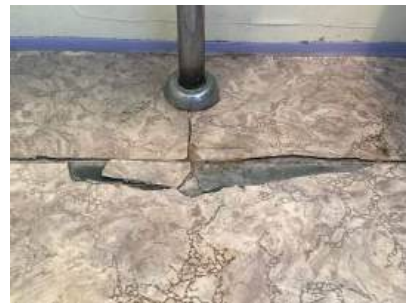
Deterioration was sighted to the floor covering at the vanity. Due to the age of the dwelling, the vinyl or the backing of the vinyl used for the floor coverings could contain asbestos, this is unknown without lab testing. Testing should take place prior to repairs or removal, disturbing this area should be avoided. Engage a floor covering specialist to cover this to help prevent a hazard.

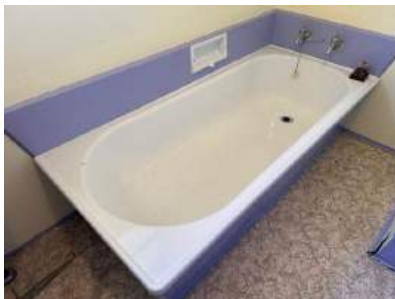
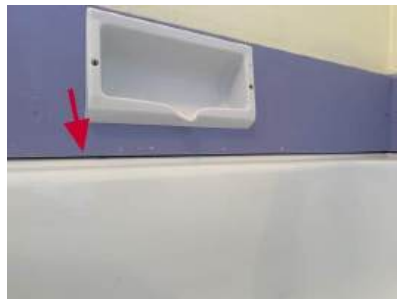
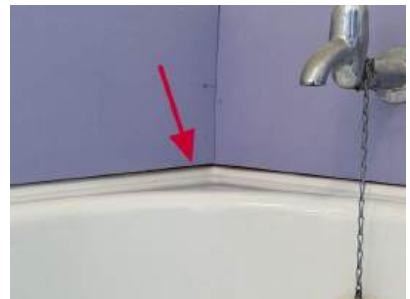
- The bath to wall junction is not sealed, the installation of a sealant would help reduce potential moisture damage to the wall linings around the bath and the flooring below the bath.

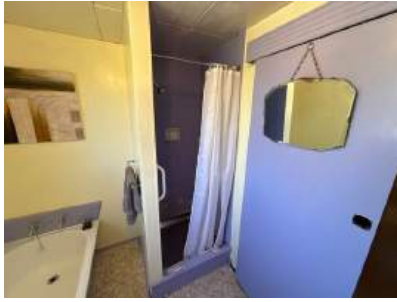
- Deterioration was detected to the shower unit. The unit does not appear watertight. Engage a plumber or shower installer now to replace this unit.

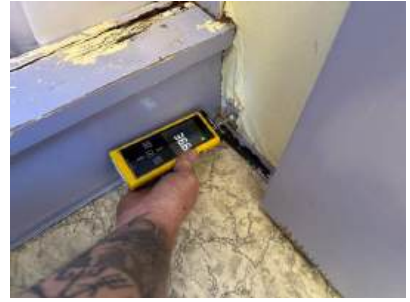
#70: Acceptable reading

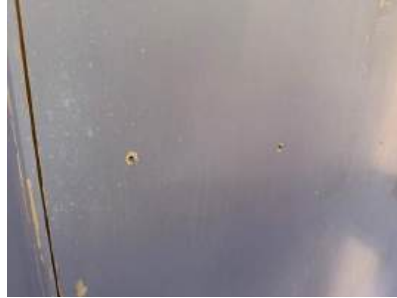
#72: nail holes exposed in liners

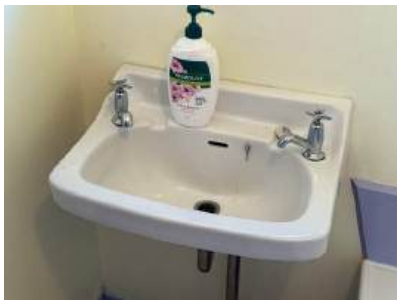
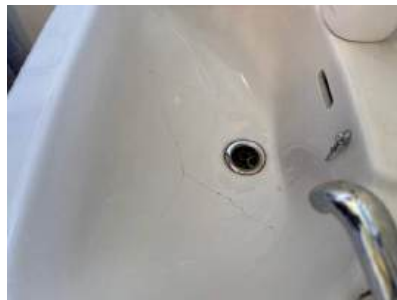
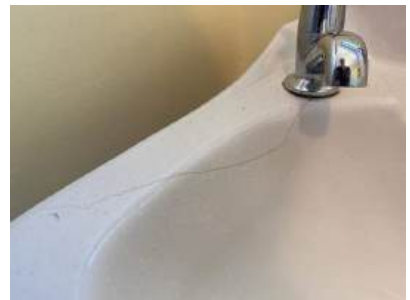
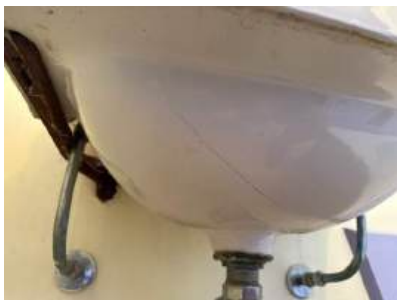
- A crack was sighted in the basin, replacement of the basin is recommended.

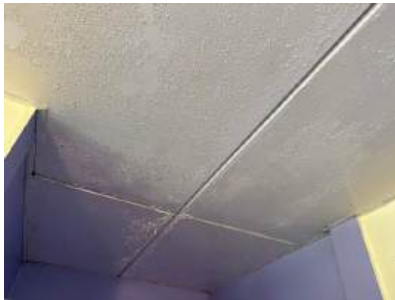
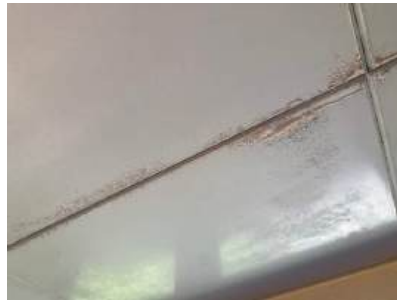
**Details:** - Condensation damage was evident to the linings, upgrades to the ventilation is recommended to help reduce this.  
**Rating:** Recommendation

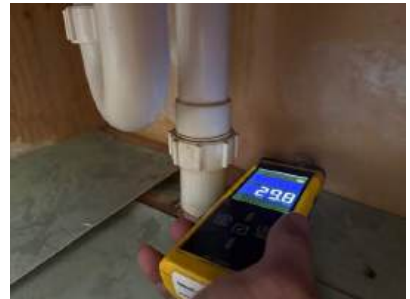
#81: Acceptable reading

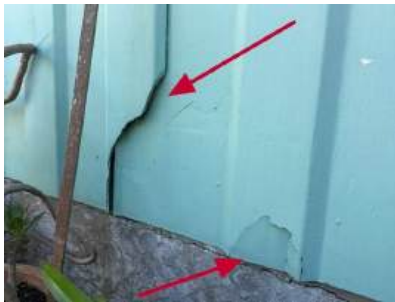
#94: Southern wall

- Cracked cladding sheets were sighted to the road facing wall and entrance area. Some of the sheets around the home did not run from the bottom of the wall to the top and had horizontal joins in place with no flashing details sighted, this is common for older construction. These could be causing water ingress in the wall cavity. The condition of the wall framing is unknown. Repairs or replacement of the cracked sheets are required now and regular and ongoing sealing of the horizontal joins should take place. A licensed builder is required to assess and determine the best repair solution.

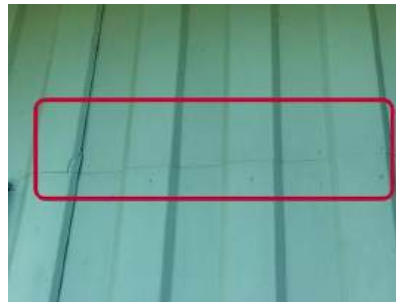
#95: no visible flashing detail at the horizontal joins

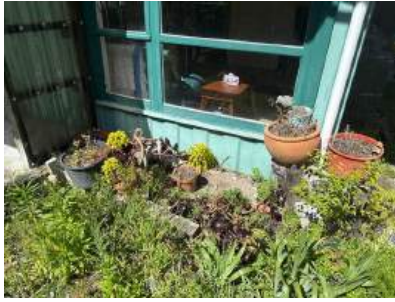
#98

- The lounge northern cladding has below-recommended clearances to the surrounding ground levels. This is detailed as a risk area for potential water ingress to occur. Creating a sufficient clearance between the cladding and the ground/garden is recommended now to help prevent potential deterioration of the cladding and water ingress to the wall cavity.

Minor Maintenance

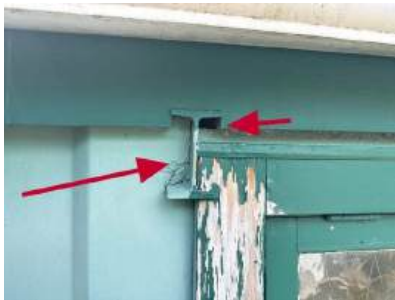
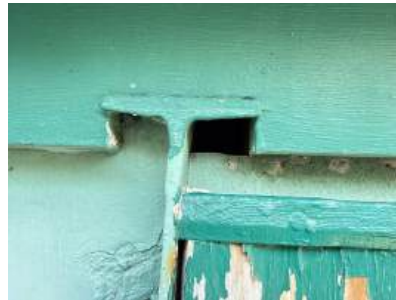
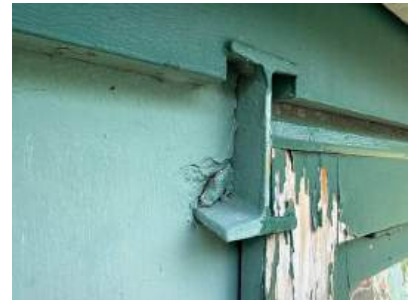
**Cladding Penetration Details:** - The steel framing members pass through the cladding and gaps were sighted. These are higher-risk design features that could potentially cause water ingress into the wall cavity. The penetrations require sealing around the perimeter to ensure they are watertight. A licensed builder should be engaged to complete the work. These areas should be regularly maintained and monitored.

**Rating:** Minor Maintenance

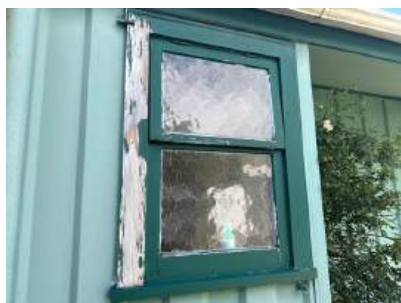
#103

**Timber Joinery Details:** - General deterioration to the paint coating and glazing putty deterioration was sighted to some units. This can allow water to sit on the timber joinery, which could lead to rot. Repairs to the paint coating and glazing putty are required to help seal and protect the timber. A trade-qualified painter should be engaged to complete the work. Also; timber decay was detected in the windows photographed below. A licensed builder should be engaged to repair or replace the defective timber. Further decay could lead to potential water ingress in the wall cavity.

- Gaps were sighted at the joinery to cladding junctions in areas around the home, this could lead to water ingress with wind driven rain. Sealing these junctions will help prevent this, a painter could complete.

**Rating:** Action Required

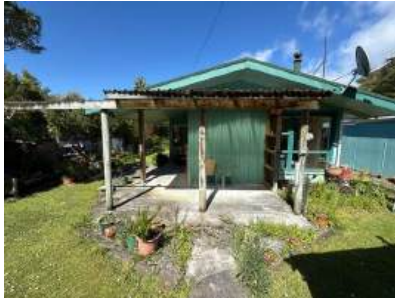
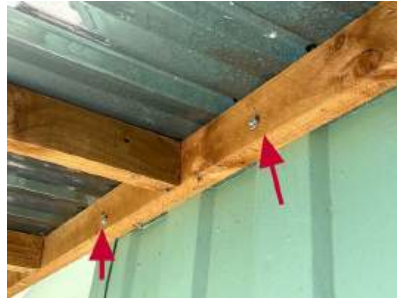
- A small verandah has been constructed, this has been directly attached to the dwelling and no flashing detail was in place. This could lead to water ingress around the bolt penetrations (the moisture levels were acceptable to the internal side of this area at the time of inspection) As a matter of best practice a sufficient flashing should be considered to help prevent the chance of future issues.

Minor Maintenance

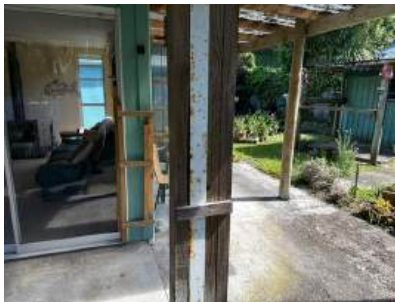
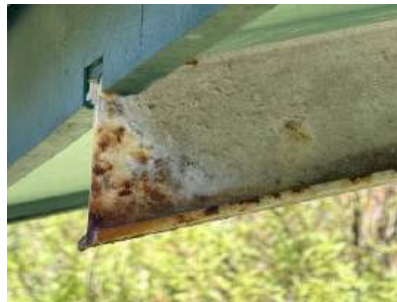
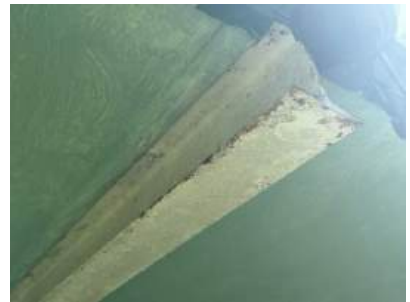
Rust was sighted to the exterior steel framing members, this is common for older homes, sanding back, rust treatment and re-coating should take place to help prevent further rusting. A painter or builder would completed.

Minor Maintenance

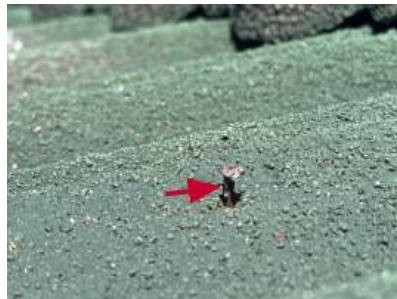
#129: lifted nail

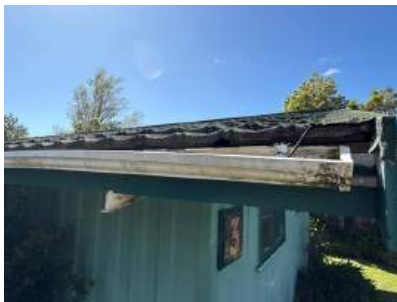
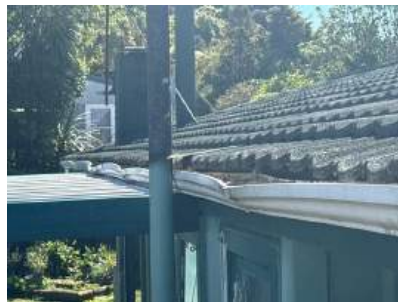
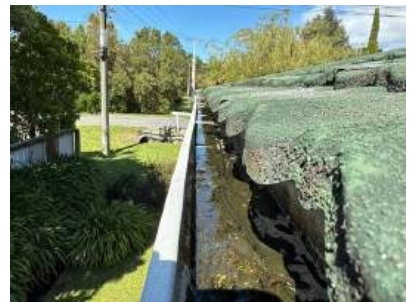
- The gutters were holding water as they were falling away from the downpipes and have warped. This could cause the guttering to overflow under rain. Replacement of the guttering and pitching the guttering towards the downpipes is recommended to prevent overflowing and excess water around the home. A licensed roofer/plumber should assess and complete.

Minor Maintenance

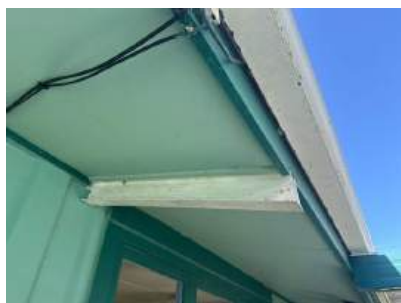
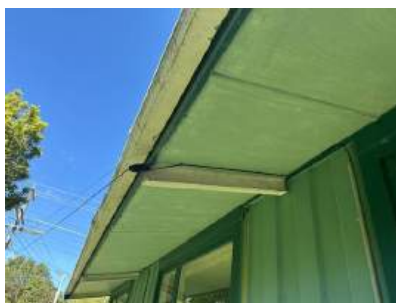
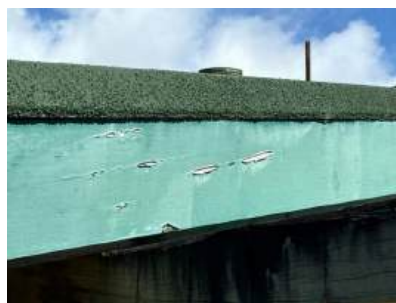
- Minor deterioration to the paint coating was sighted in localised areas; improvement of the paint coating would help protect and seal the boards/linings. A trade-qualified painter should be engaged to complete.

Minor Maintenance

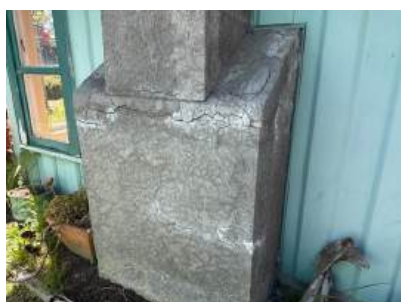
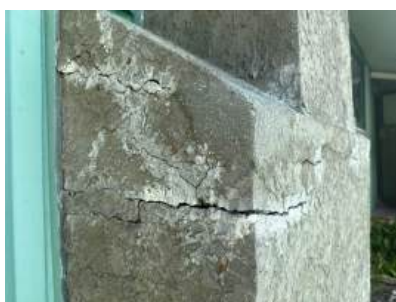
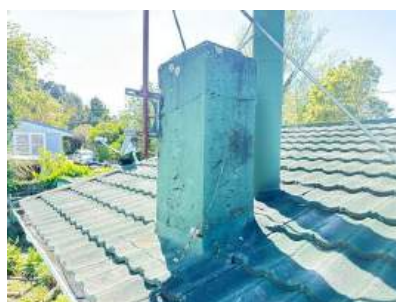
- Large cracks were sighted to the concrete chimney, which could affect the structure of the chimney. As this is no longer in use removal should be considered. This can take place by a roofer or builder.

Minor Maintenance

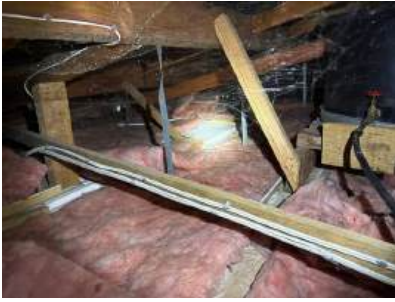
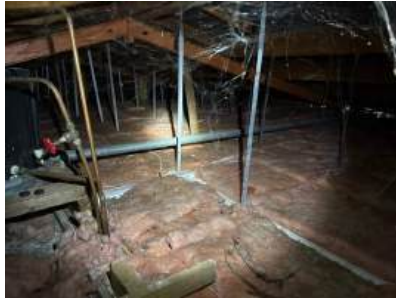
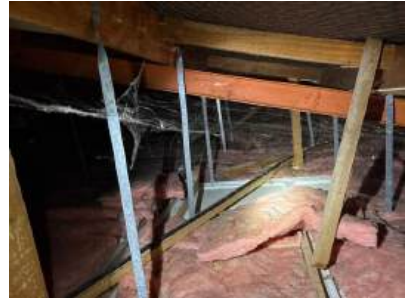
- The insulation in place is an older insulation and has degraded overtime and some gaps were sighted, upgrades can take place if desired.

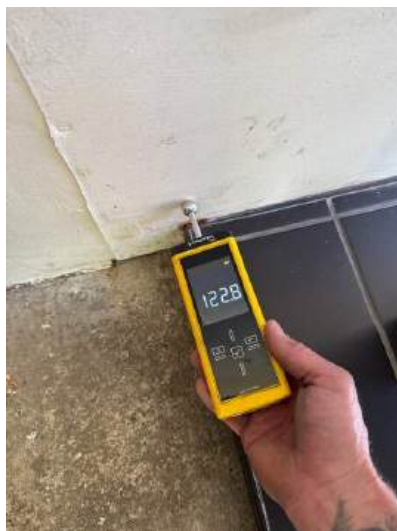
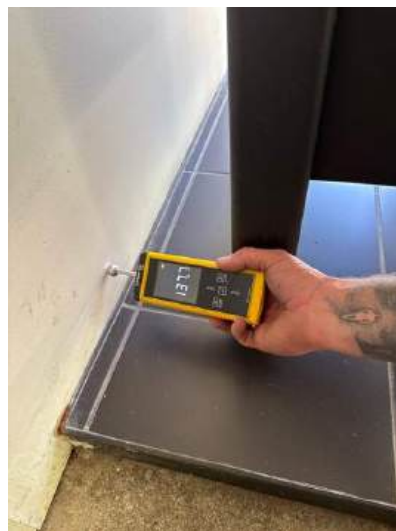
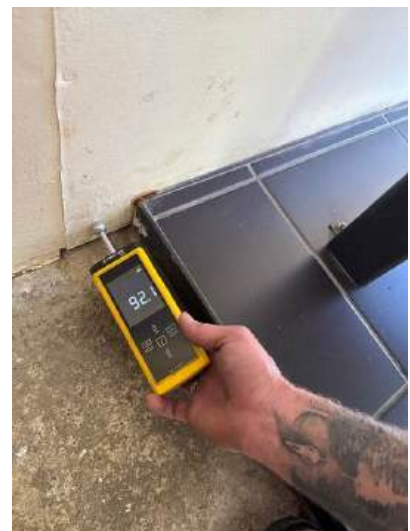
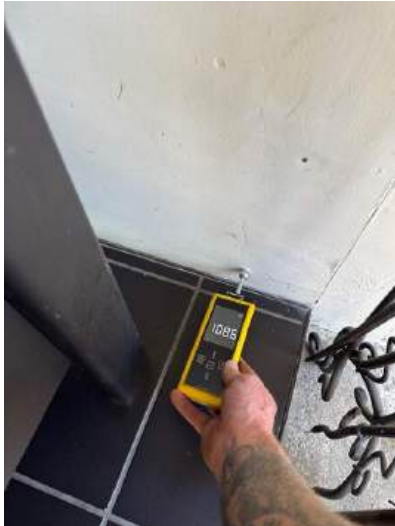
The majority of the moisture readings were acceptable, with the exception of the elevated readings located below. Further investigation and invasive testing must take place. The in-wall framing condition is unknown until this happens.

- Invasive moisture testing is required in the locations of elevated moisture readings detailed below to determine the in-wall framing condition.

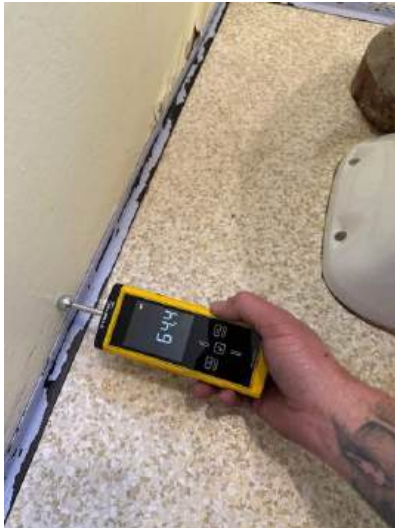
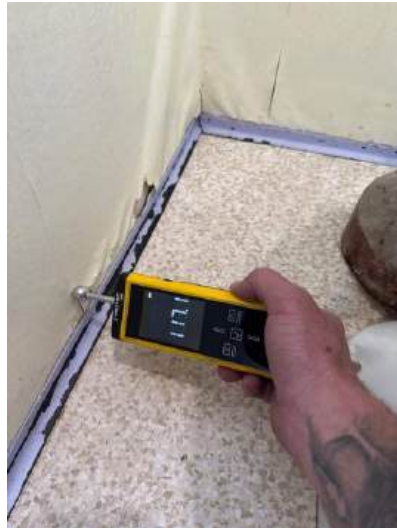
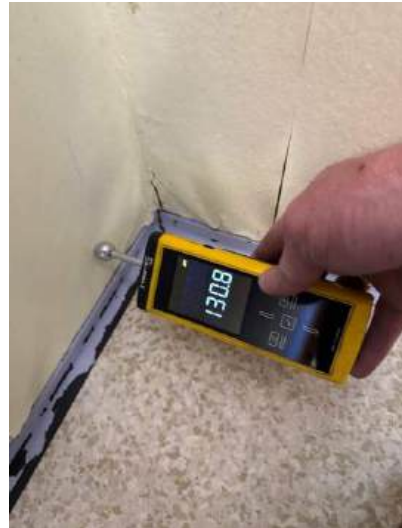
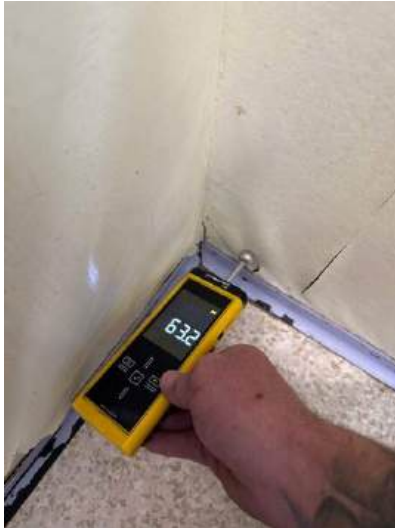
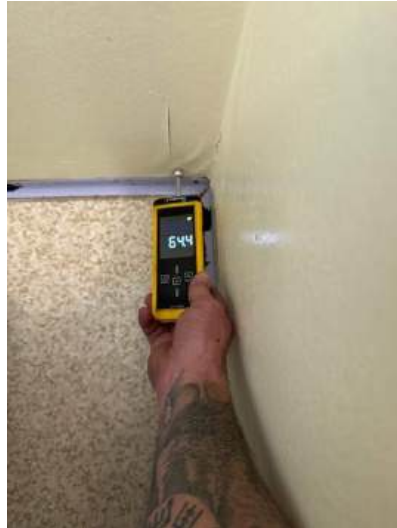
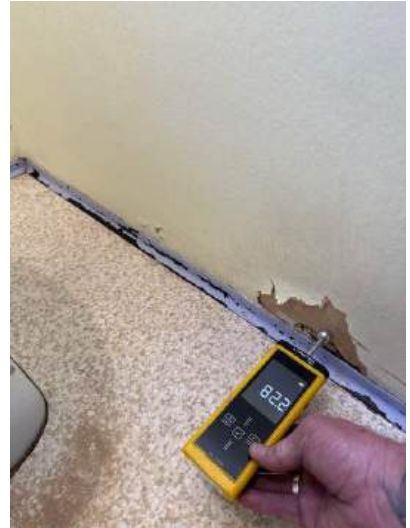
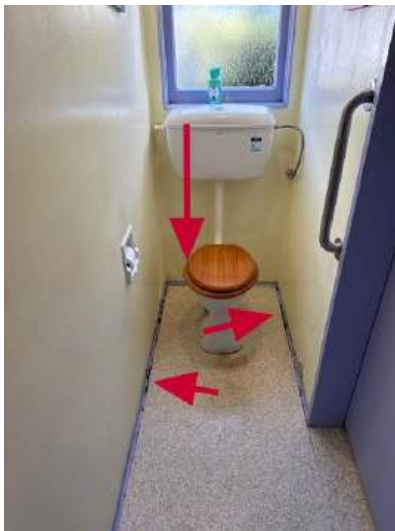
<b>Moisture Information:</b>	- Invasive moisture testing is required in the locations of elevated moisture readings detailed below to determine the in-wall framing condition.
<b>Location of Elevated Moisture Reading(s):</b>	- Toilet room walls, at bottom plate height and up to 100mm
<b>Rating:</b>	Further Investigation Required

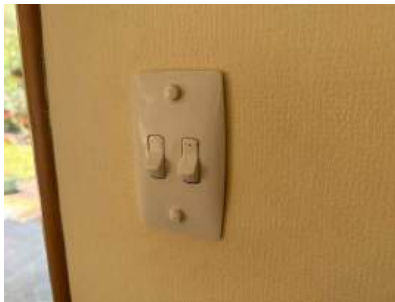
#183

Older style switches were in place, as photographed below. A licensed electrician would determine if upgrades to the switches are recommended.

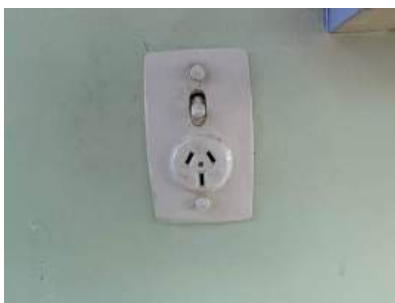
#185

Some older style hot points were still in place, as photographed below. A licensed electrician would determine if upgrades to the switch are recommended.

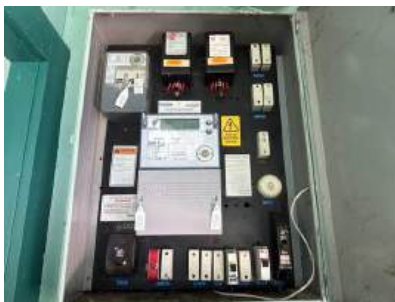
#190

A mixture of older fuses and circuit breakers were sighted to the fuse switchboard. Refer to photographs and details below.

<b>Fuse Switchboard Details:</b>	- A licensed electrician is required to inspect the fuse board to determine what fuses are in use and if upgrades are recommended.
<b>Potential asbestos switch board:</b>	- The older style switchboard could potentially contain asbestos, this is unknown without lab testing, we recommend testing prior to any remedial works taking place to this board.
<b>Fuse board location:</b>	Side of house
<b>Rating:</b>	Further Investigation

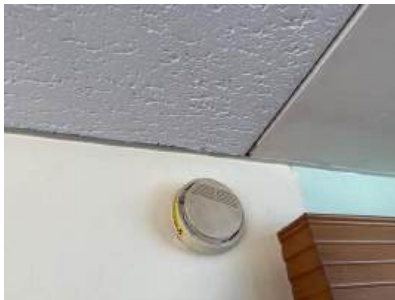
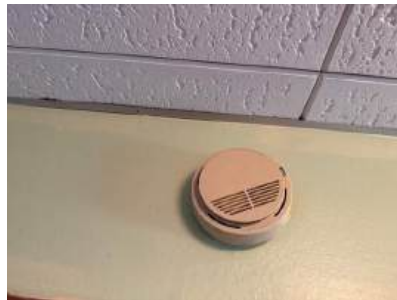
The smoke alarms were flat

I recommend installing new smoke alarms as this can be a safety risk without them. There must be at least one working smoke alarm within 3 metres of each bedroom door or every room where a person sleeps, in multi-storey or multi-level homes (including split levels) there must be at least one smoke alarm on each level or storey.

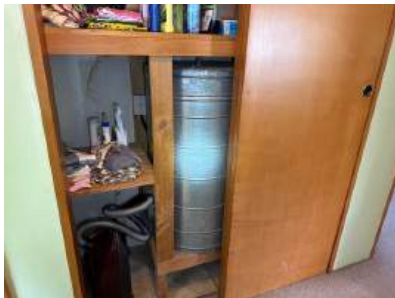
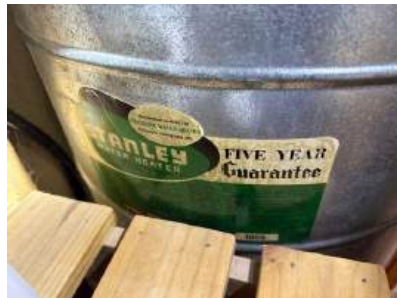
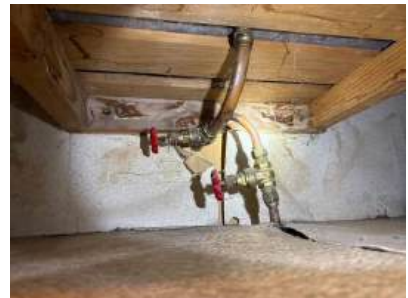
**Age:** Over 20 years  
**Seismic straps:** No seismic straps were in place, seismic straps are installed to prevent movement of the hot water cylinder during an earthquake.

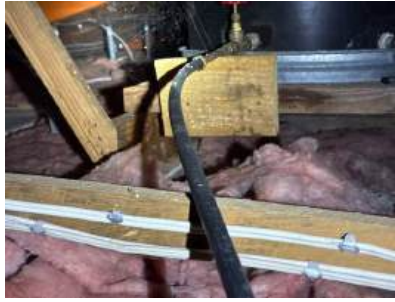
**Plumbing Details:** An unmarked black plumbing pipe was visible in the roof space. Due to the age of the dwelling, investigation by a plumber is recommended to help determine if this is dux qest piping  
**Rating:** Further Investigation

#204: black pipe in roof space

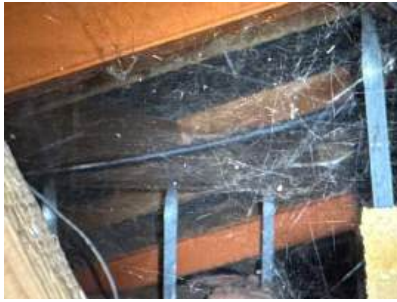
#206: black pipe in roof space

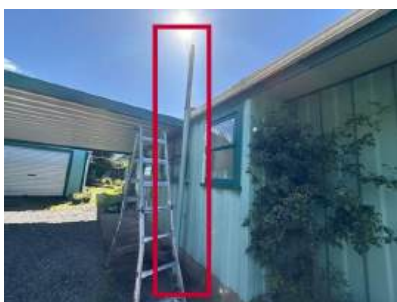
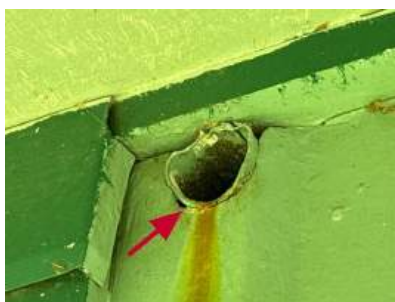
- The vent pipe outside the laundry is of fibrous cement material, due to the age of the dwelling this could contain asbestos, this is unknown without lab testing. CheckHome recommend testing prior to any remedial or upgrading works taking place that could disturb the pipe potentially releasing fibres.

Minor Maintenance

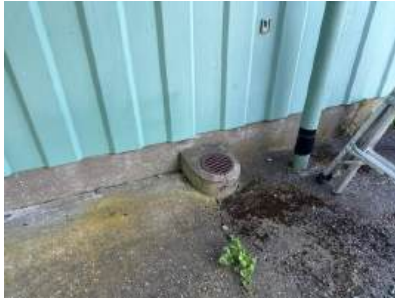
#212

The gully traps were free of movement/cracking and no blockages were sighted.

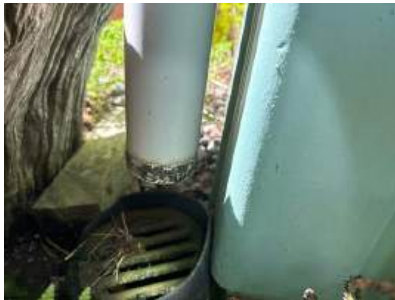
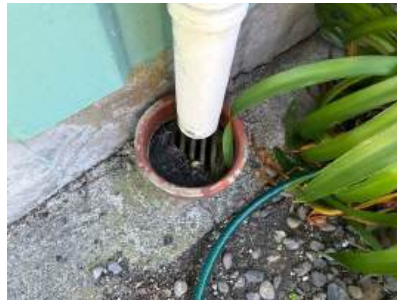
The visible down pipes appeared to be connected to the stormwater system.

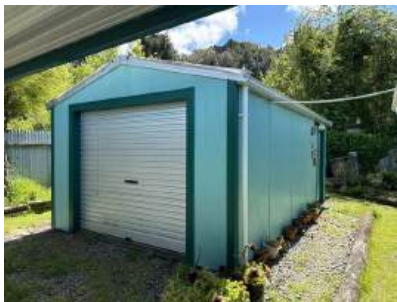
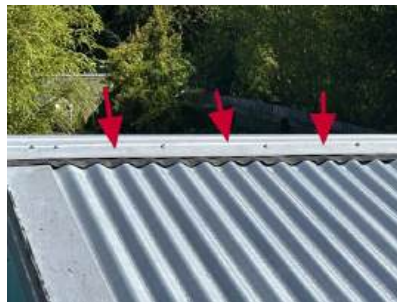
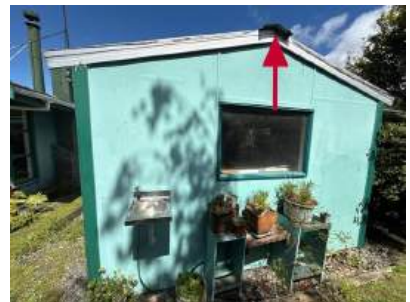
- The garage roof ridge flashing has not been completed at the rear of the garage, folding down is recommended to help ensure the ridge to barge flashing junctions are watertight. The flashing has also not been secured in an appropriate screw pattern for a very high wind zone, additional screws should be installed to help prevent the chance of uplift.

Minor Maintenance

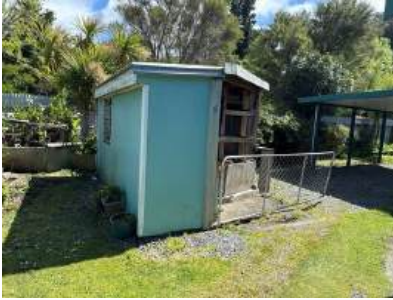
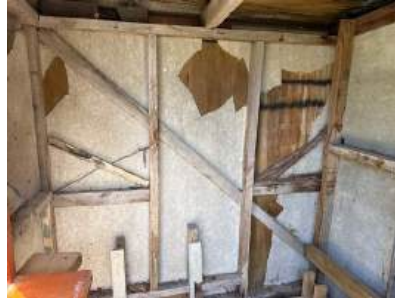
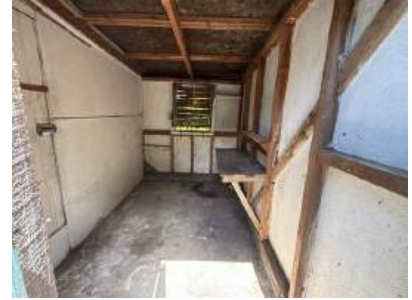
The garden shed was in poor condition. Repairs or removal can take place.

**Out Building Information:** - Due to the age of the dwelling, the fibre cement sheeting used for the cladding could contain asbestos. This is unknown without lab testing. CheckHome advises testing prior to any remedial work.

**Rating:** Observation

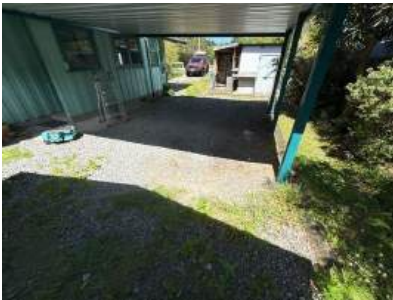
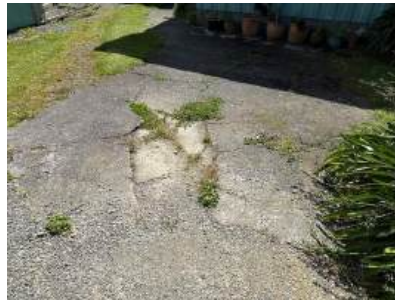
**Driveway/Path Details:** - General cracking was sighted, this is commonly due to general settlement. Monitor these, and should they worsen over time, have a concrete specialist or landscaper assess to determine the best repair method.

**Rating:** Observation

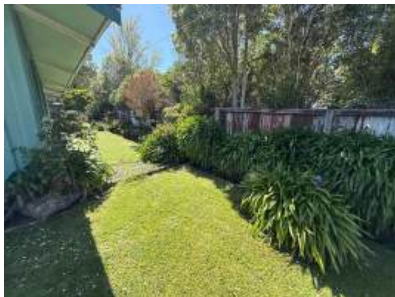
- A creek was sighted running through the side of the property, this can be a flood issue and regular clearing and maintenance will be required to help allow correct flow. It is recommended that the council files are checked in regards to any past flooding that may have been recorded and the local flood maps checked to understand this risk. During wet periods, water buildup could occur on the property and potentially against/under the dwelling. Surface water upgrades may help reduce this. Consideration as to engaging a drainage specialist should take place to assess and determine if surface water upgrades are recommended.

Further investigation

#251: Eastern side of property
