**Information request – CLM/2011/039099 - 21A Montclare Avenue, Ilam, Christchurch 8041.**

# EARTHQUAKE RECOVERY (EQR) DOCUMENTATION

## Statement of Claim Checklist / Repair Strategy

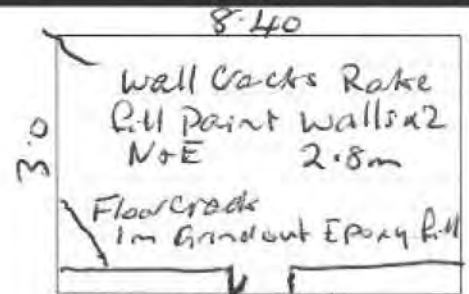
Outbuilding/Garage N

Ridge Cap Mortar  
Remove and Replace  
4.60m  
Reseat tiles 3m<sup>2</sup>

Mortar cracks Grind  
out Remortar  
8.30m

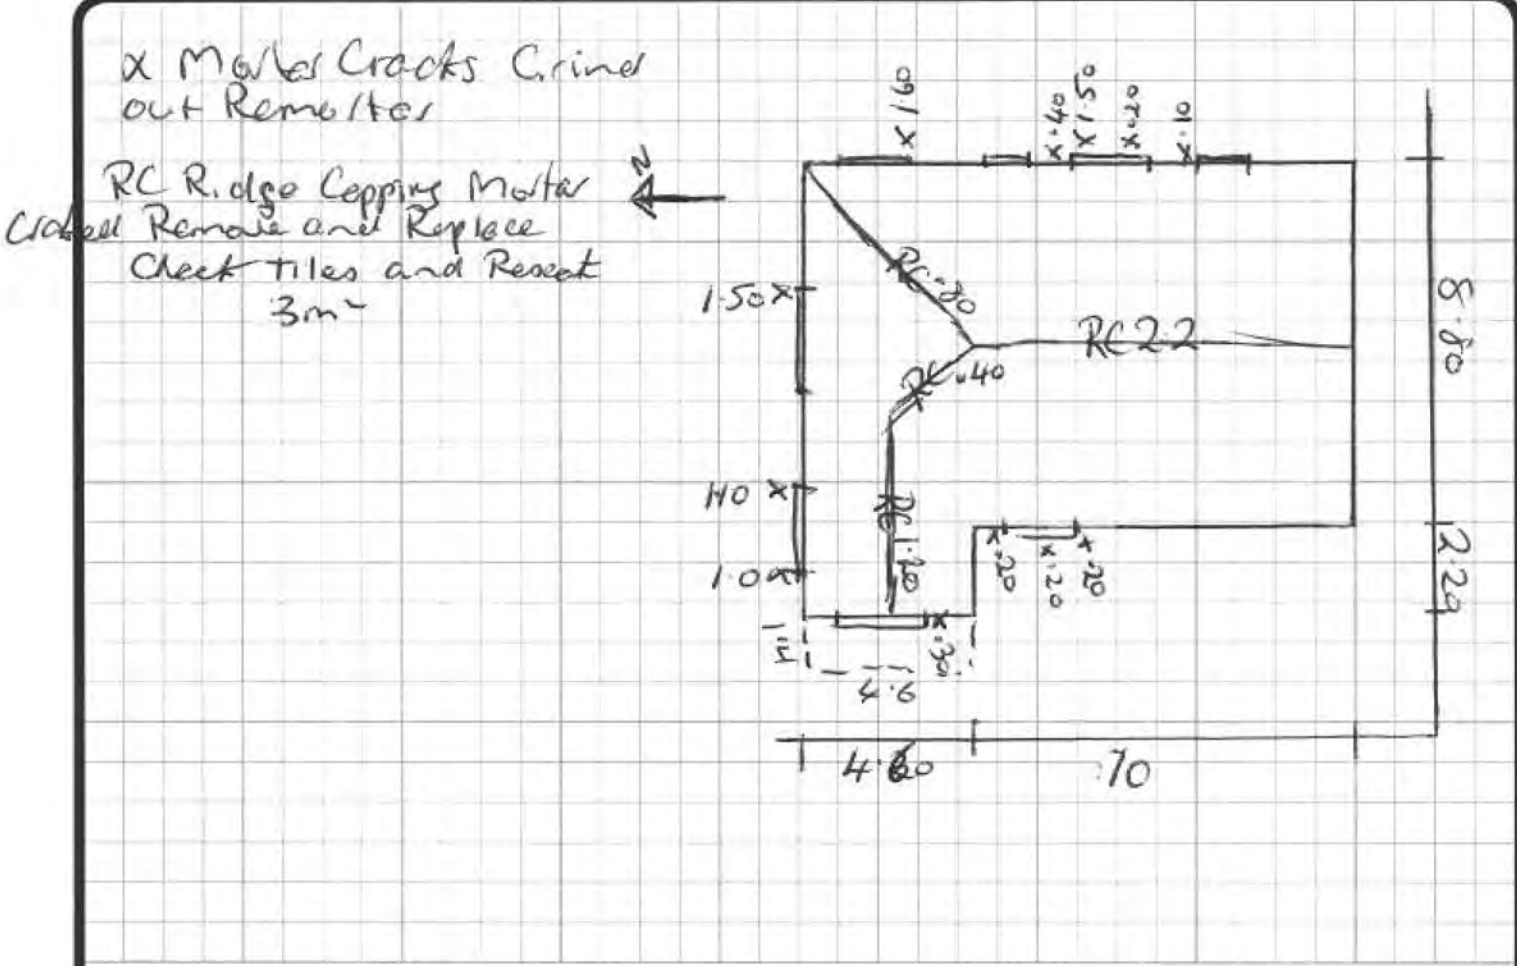
Area m <sup>2</sup> :	<i>100</i>
Stud Heights:	<i>2.4.</i>
Wall Finish:	<input checked="" type="radio"/> Wallpaper <input type="radio"/> Plastered <input type="radio"/> Paint Finish
Other:	_____
Services:	Specify Damage: _____
Chimneys:	Construction Type: <i>N/A</i> Height: _____ Damage Description:   Above Roof    Below Roof    Total Repair
Foundations Damage:	Timber    Concrete Ring <input checked="" type="radio"/> Concrete Slab    Other (Specify): _____ Minor    Moderate    Severe House Moved off Foundations? _____ Concrete Slab Cracked? Crack Width: ..... Crack Length: .....
Roof:	Framed <input checked="" type="radio"/> Trussed Type:    Clay Tiles <input checked="" type="radio"/> Concrete Tiles    Rolled Metal    Other Damage: _____
Cladding Type:	Weatherboard <input checked="" type="radio"/> Brick Veneer    Hardi Plank    Other

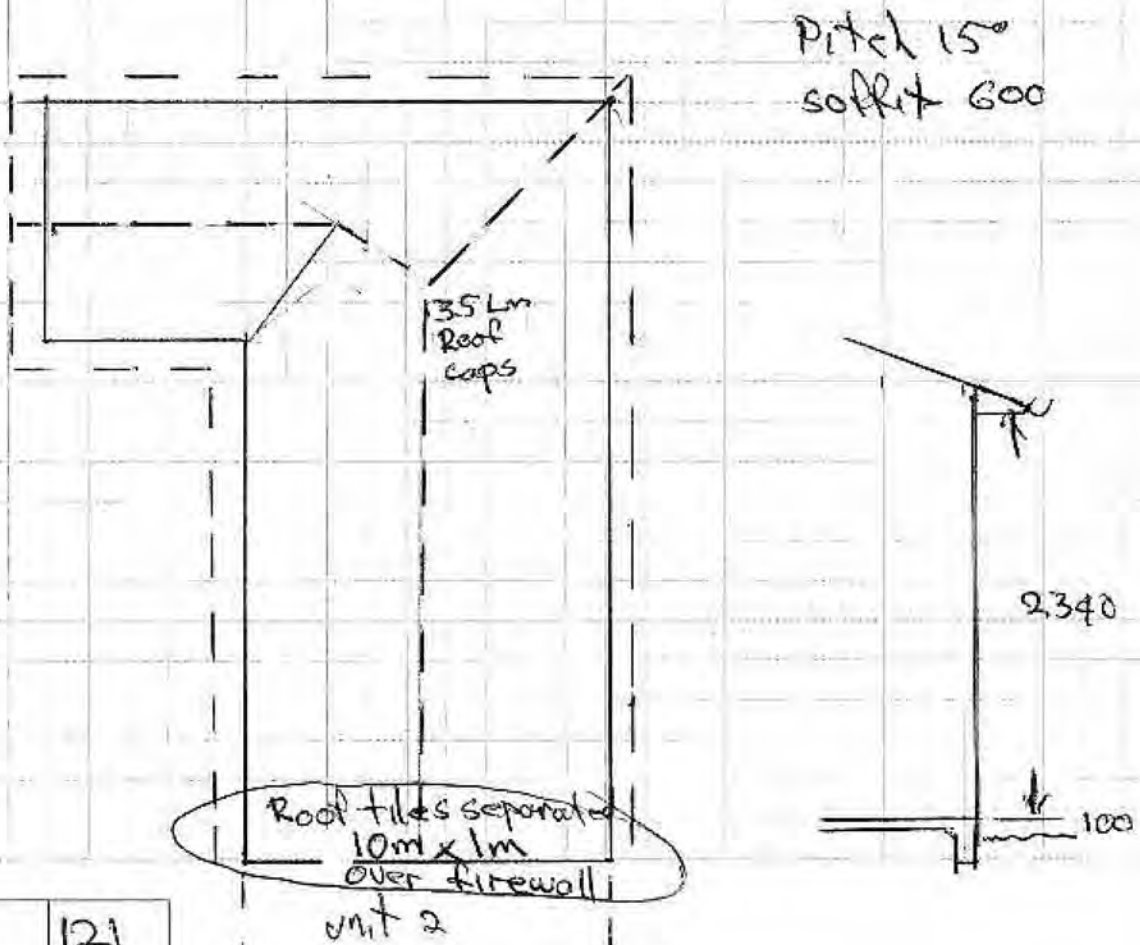
Area m <sup>2</sup> :	121
Stud Heights:	2.4
Wall Finish:	<u>Wallpaper</u> Plastered Paint Finish
Other:	
Services:	Specify Damage:
Chimneys:	Construction Type: Height: Damage Description: Above Roof Below Roof Total Repair
NO	
Foundations Damage:	Timber Concrete Ring <u>Concrete Slab</u> Other (Specify): Minor Moderate Severe House Moved off Foundations? Concrete Slab Cracked? Crack Width: ..... Crack Length: .....
Roof:	Frame <u>Trussed</u> Type: Clay Tiles <u>Concrete Tiles</u> Rolled Metal Other Damage:
Cladding Type:	Weatherboard <u>Brick Veneer</u> Hard Plank Other
