Scope of Works

Assessment of Property at 6 JELLICOE STREET, SOUTH NEW BRIGHTON, CHRISTCHURCH 8062 on 19/09/2011

Address	6 JELlicoe STREET, SOUTH NEW BRIGHTON, CHRISTCHURCH, 8062	EQC Claim Number	CLM/2011/101565
Hazards	None evident	EQC Assessor (L,F)	Bublitz, Dave
Inspection Date	19-Sep-2011	Placard	No Sticker
		EQC Estimator (L,F)	Richards, Brad

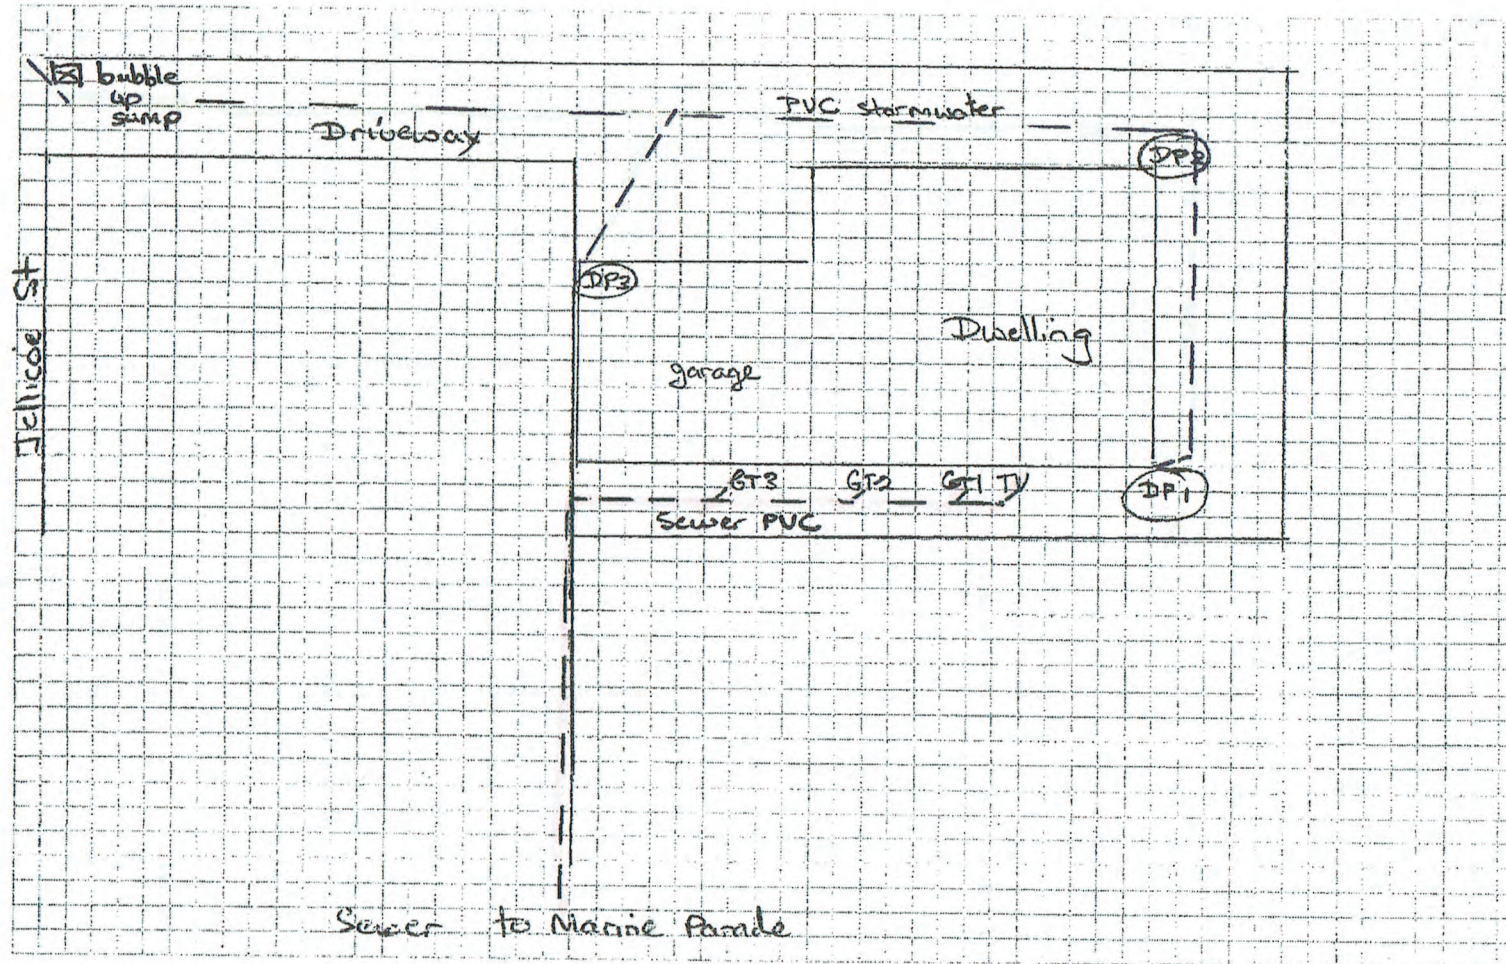
As Built (Damage) / Proposed Repair

The drains are all PVC. The contractor opened the P Pan toilet for access and attempted to camera survey the sewer drain from this access, unfortunately the nearby square junction would not allow the camera to access the remainder of the drain. The sewer drain is a separate line that runs through a neighbouring property and it was difficult to arrange any other access point. As the storm water drain incurred no damage and there have been no issues with the sewer it has been classed as having no earthquake damage.

The stormwater drain was water blasted from the bubble up sump near the mail box and was cleared of silt and debris. The drain was camera surveyed from DP1 downstream and no earthquake damage was found. The stormwater drain is all PVC.

* NO repair required
