## RESIDENTIAL HOUSE INSPECTION

69 Bower Ave  
Christchurch, Canterbury Region 8083

06/11/2025

Kiwi House Inspections

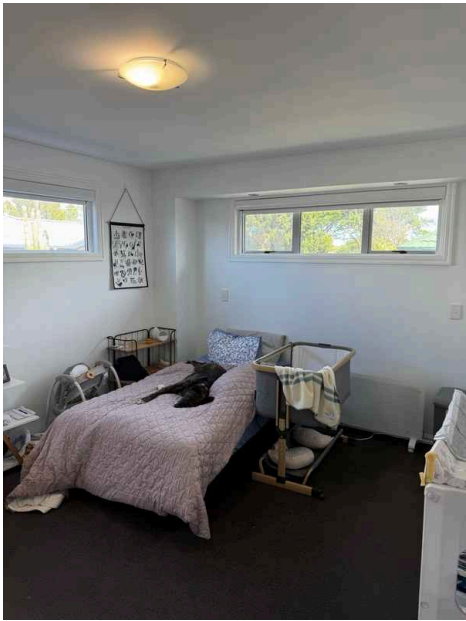
23.2.1 Exterior Joinery  
**SPACER BAR HAS MOVED**  
Unit is sound

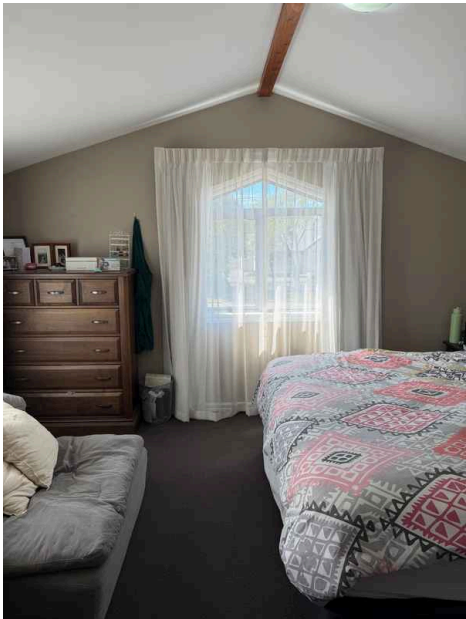
24.1.1 Internal Linings

**WEAR & TEAR TO WALLS NOTED**

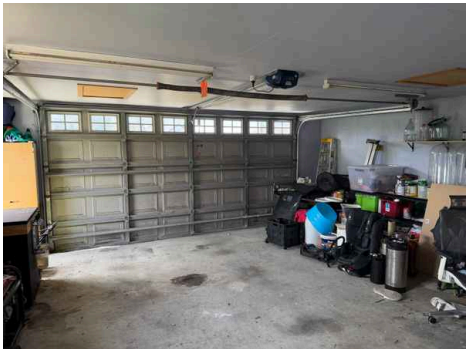
28.2.1 Internal Linings  
**WEAR AND TEAR NOTED .**

28.4.1 Garage Door  
**IMPACT DAMAGE IS NOTED**  
impact damage to the damage door is visible.

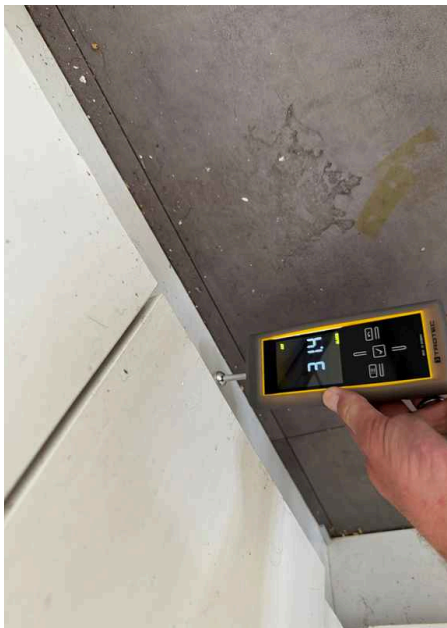
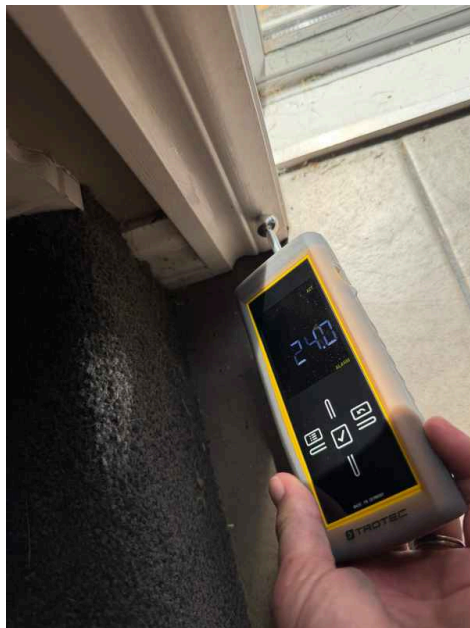
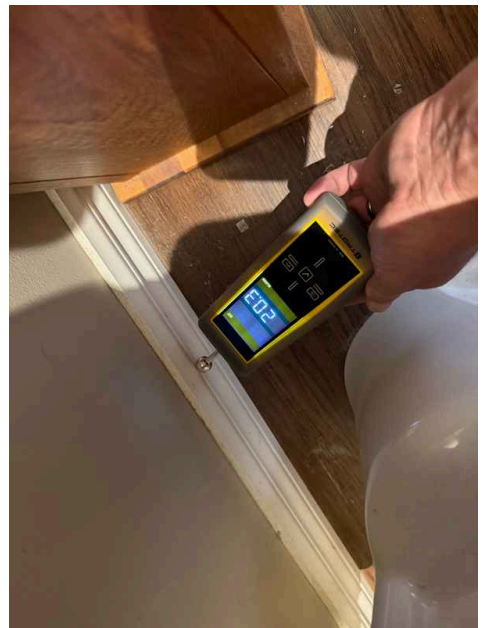
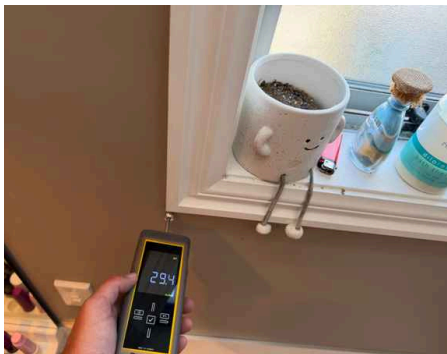
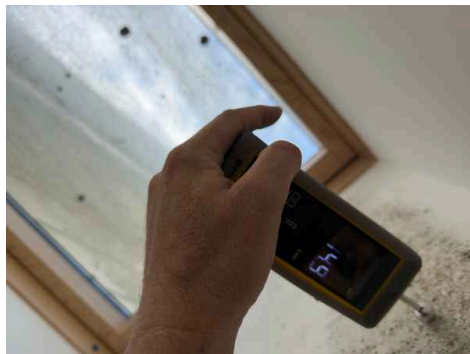
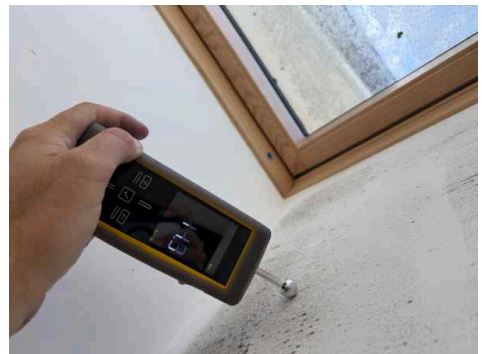
**Moisture : A base reading of**  
16

**Moisture : Readings range from**  
11- 32

Photos are samples of readings taking around the dwelling.
