PROPERTY CHECK EXPRESS PLUS WEATHERTIGHTNESS REPORT

Job Number	54387
Client	Giacomina King
Property Inspected	29 Saracen Avenue, Northwood, Christchurch
Inspection Date	13 April 2026
Building Surveyor	Darin Devanny
NZIBS Registration Number	BSI0100
Weather Conditions	Overcast
Scope of Report	Visual inspection of the buildings that are listed in this report for the purpose of a residential inspection in accordance with NZS4306: Residential Property Inspections.
Report Ordered By	Giacomina King - Vendor
Orientation	For the purpose of this report, the main entrance to the house is on the west elevation.

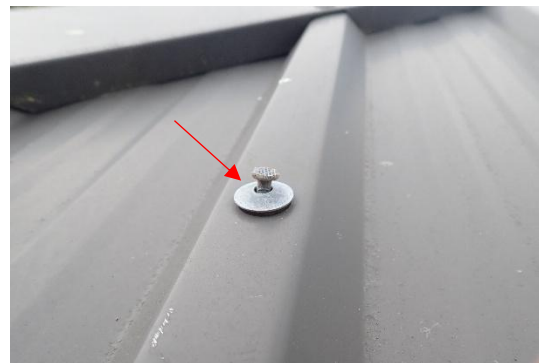
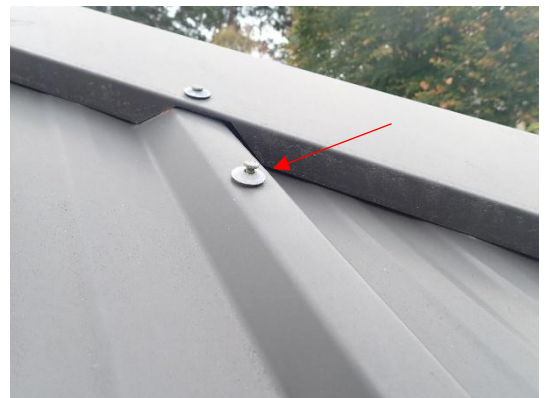
There are several proud nails on the western, northern, and eastern elevations. It is recommended that these are replaced by roof screws or correct fixings to prevent water from entering the gaps and into the roof space.

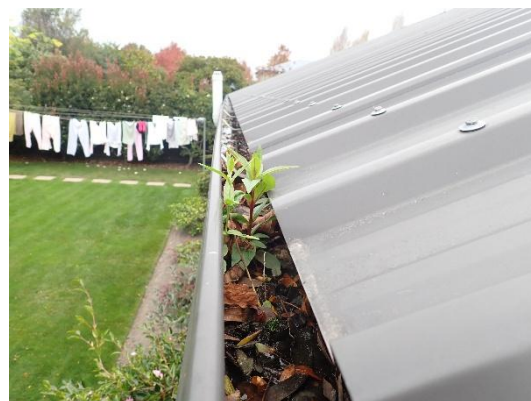
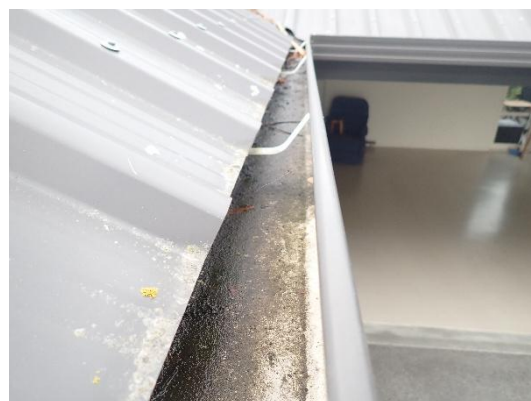
There are areas of organic debris build-up in the spouting. This should be cleared as part of routine maintenance to allow the free flow of water to the downpipes.

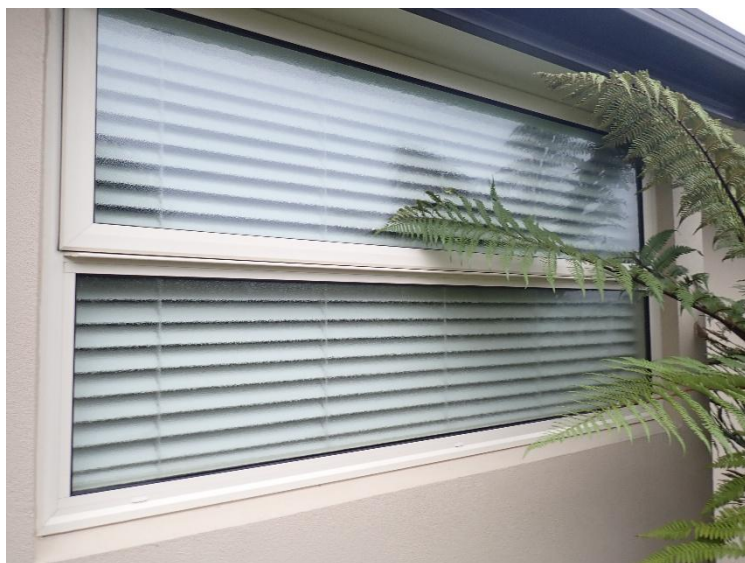
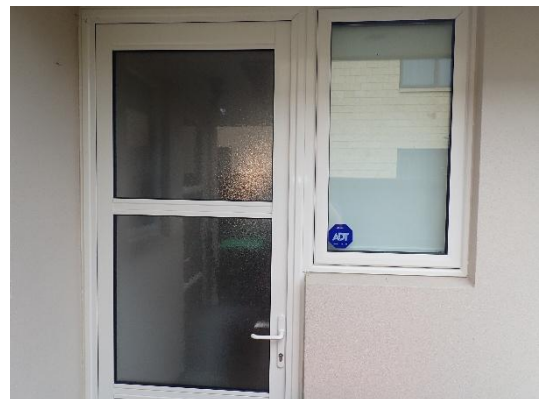
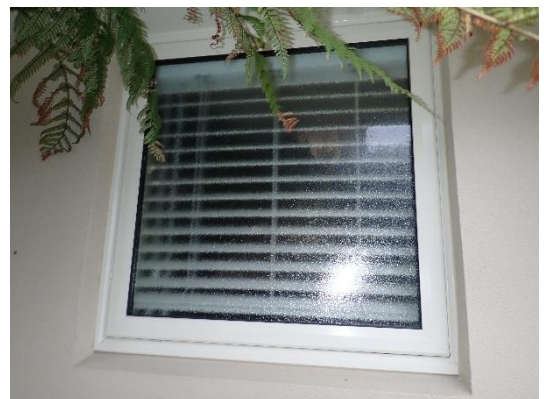
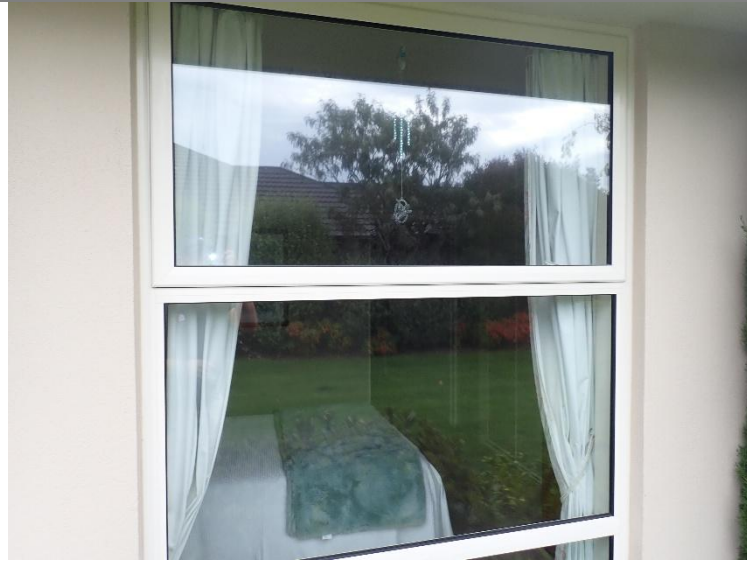
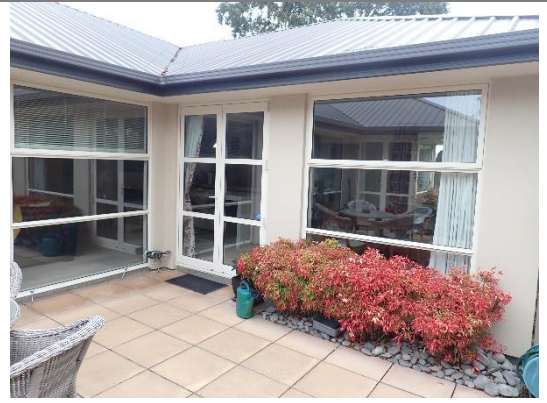
EXTERIOR WINDOWS AND DOORS
Aluminium - double glazed

No significant defects identified.

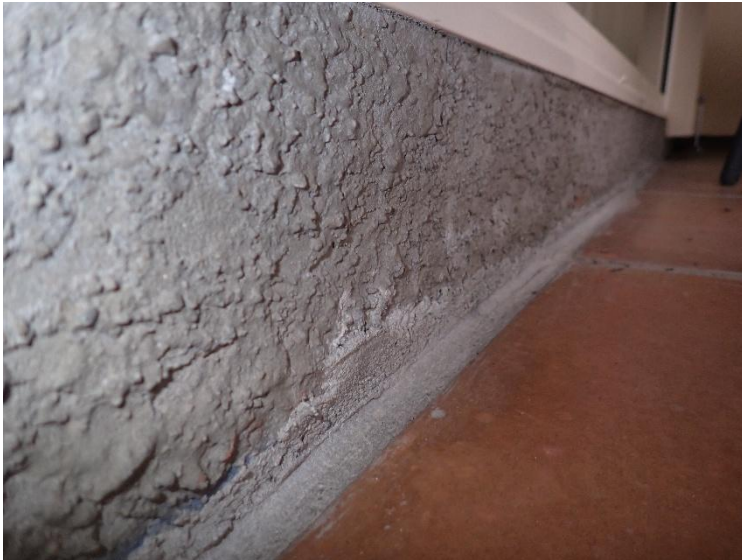
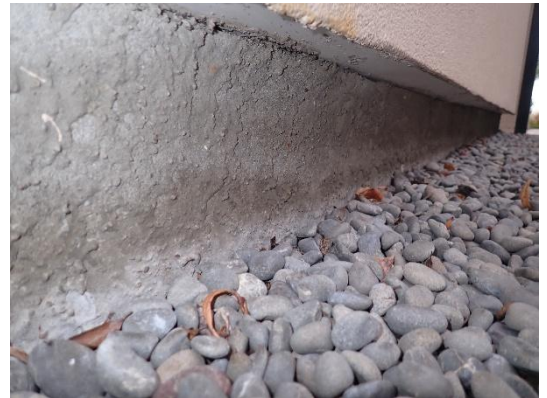
PERIMETER FOUNDATION
Concrete strip

No significant defects identified.

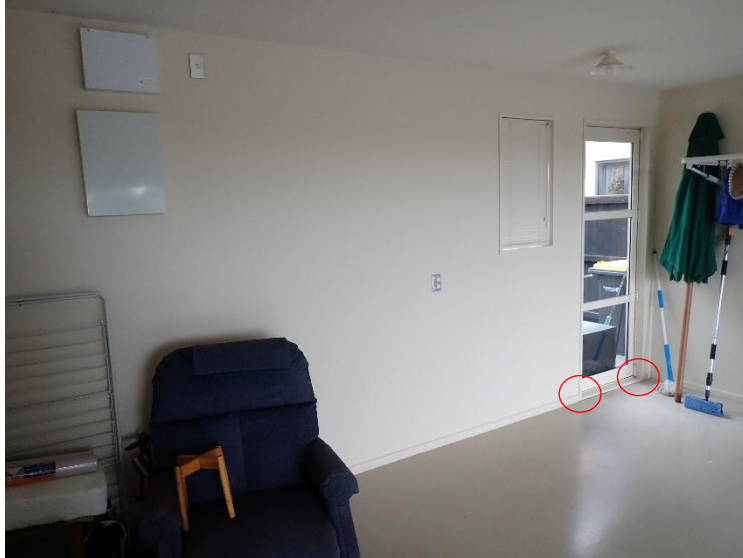
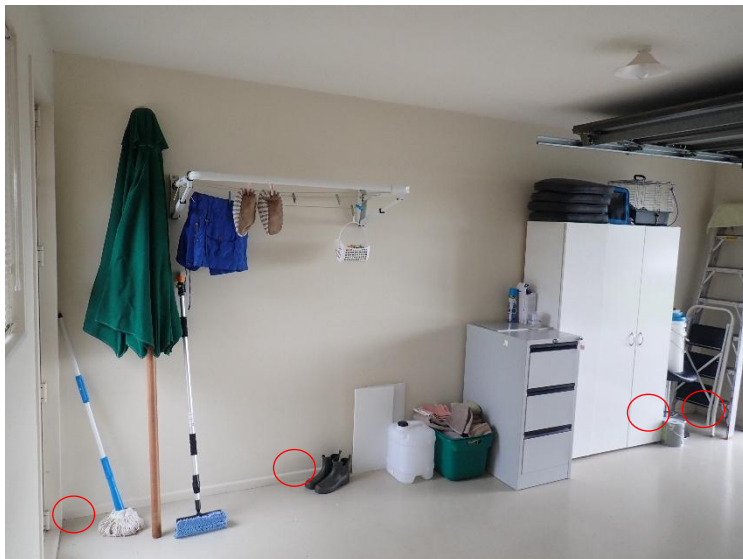
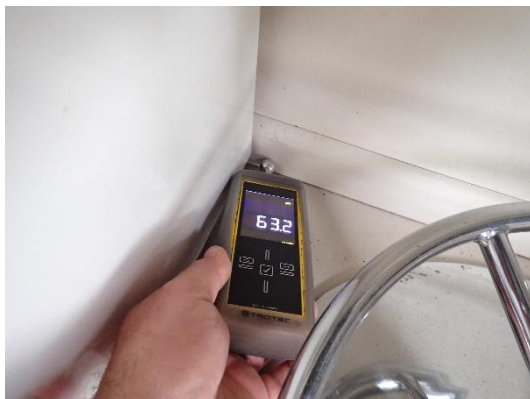
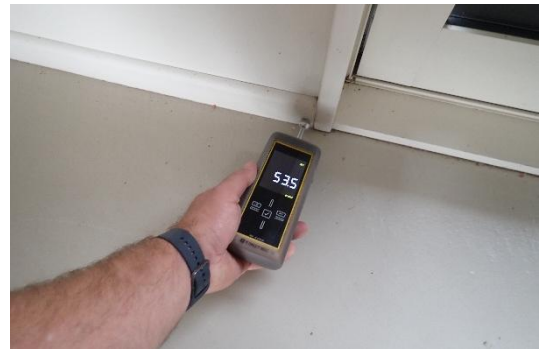
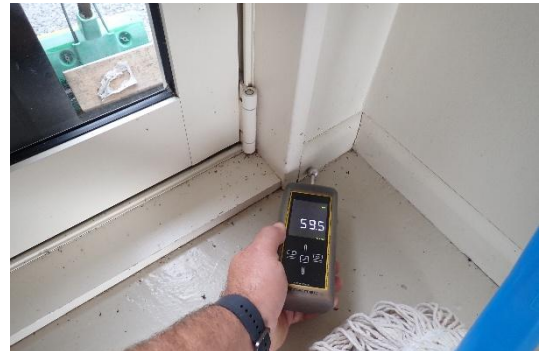
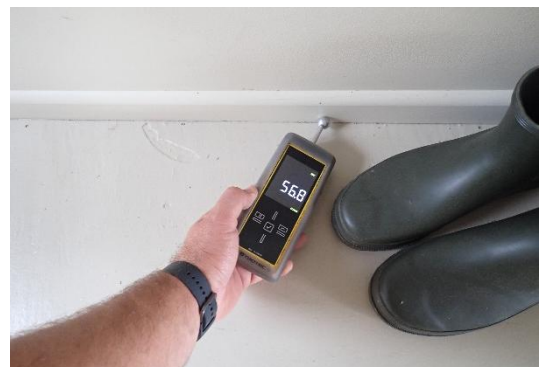
GARAGE

No significant defects identified.

Normal readings returned from moisture scanner.

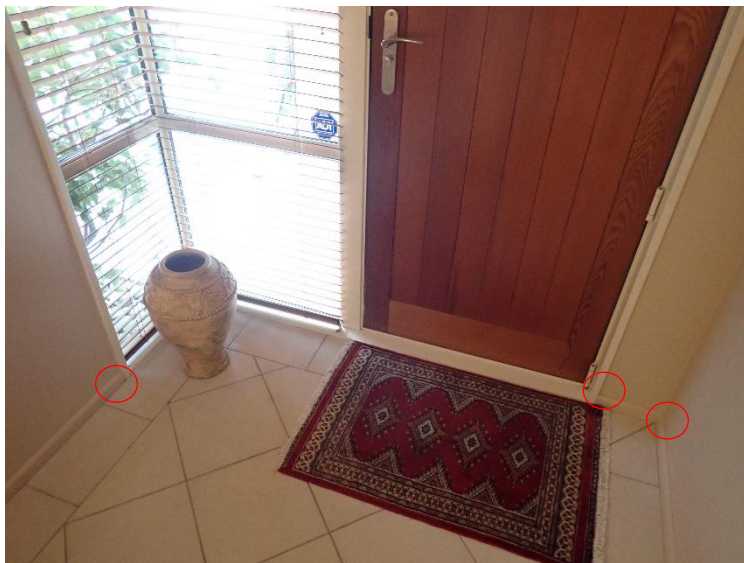
ENTRANCE / HALLWAY

No significant defects identified.

Normal readings returned from moisture scanner.

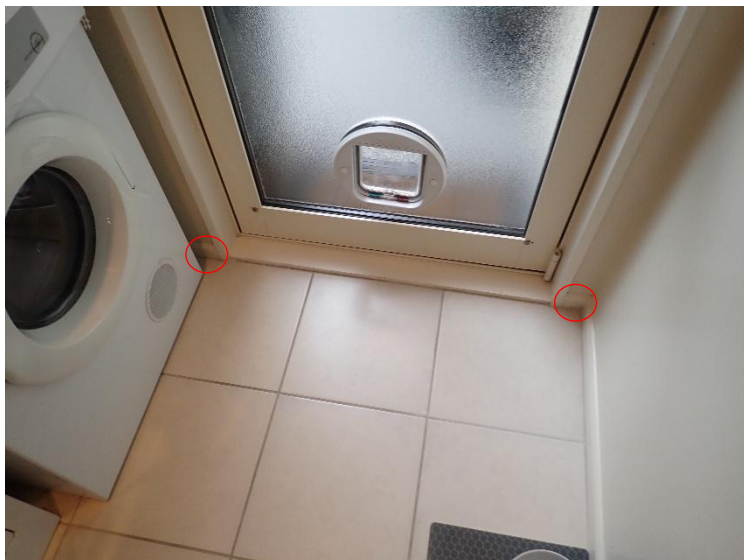
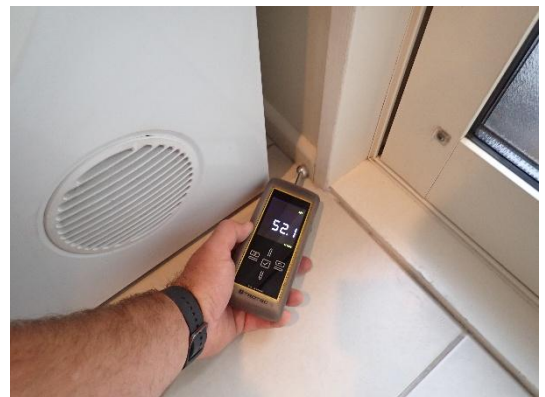
LAUNDRY

No significant defects identified.

Normal readings returned from moisture scanner.

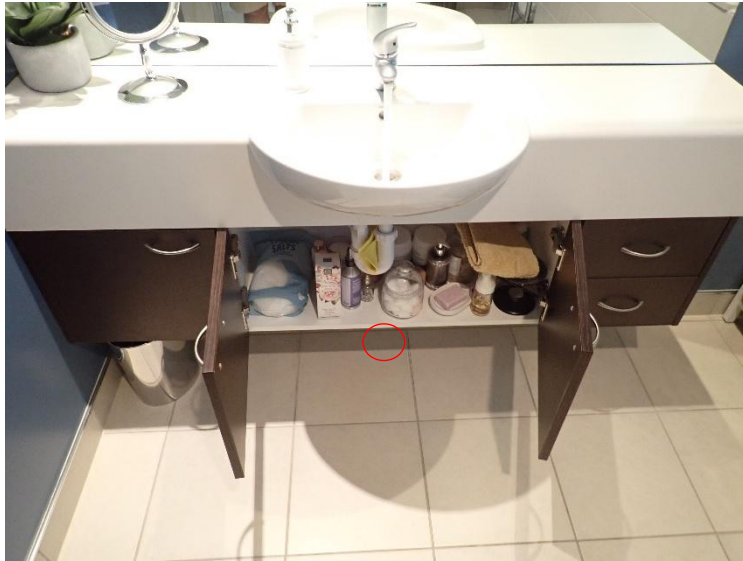
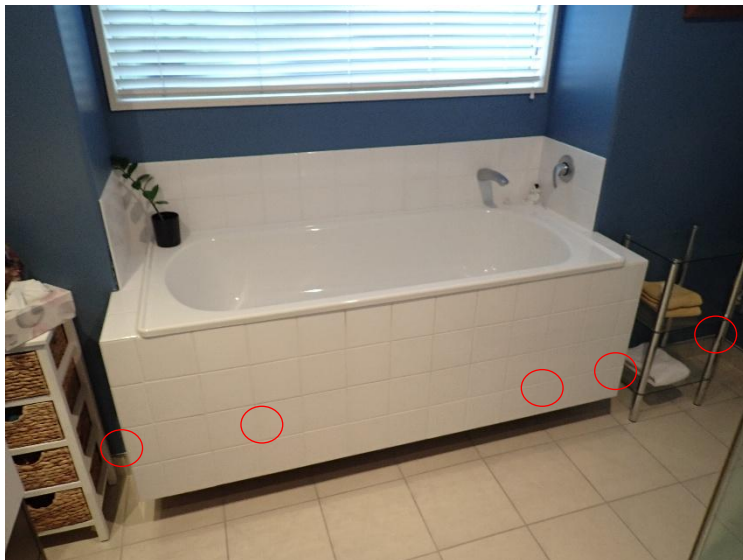
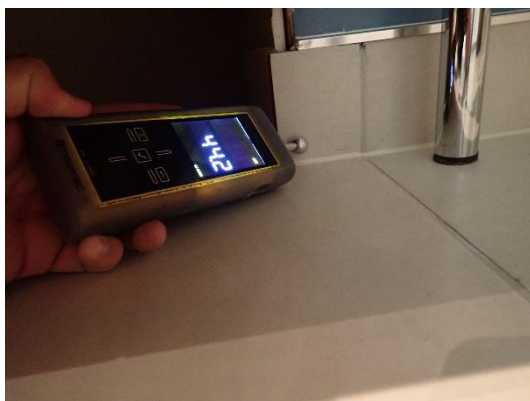
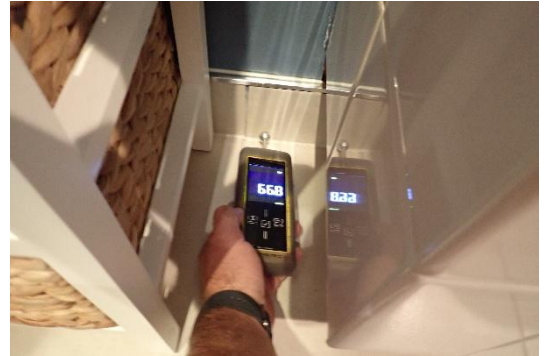
BATHROOM

No significant defects identified.

Normal readings returned from moisture scanner.

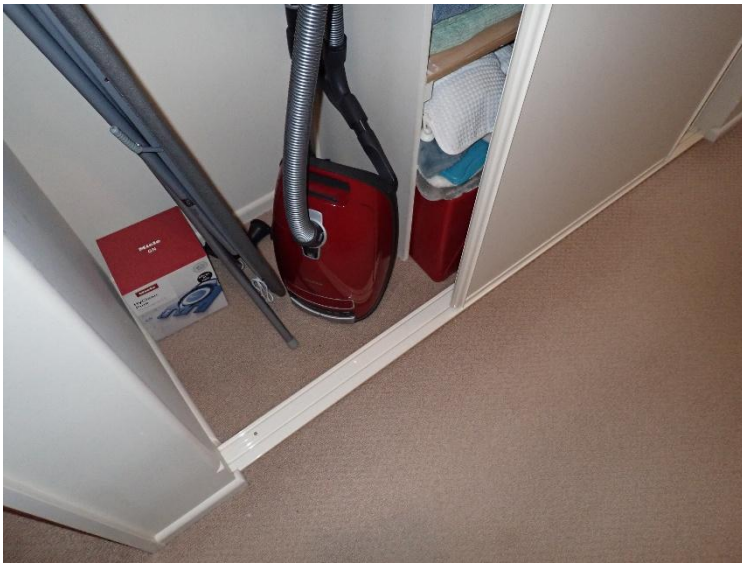
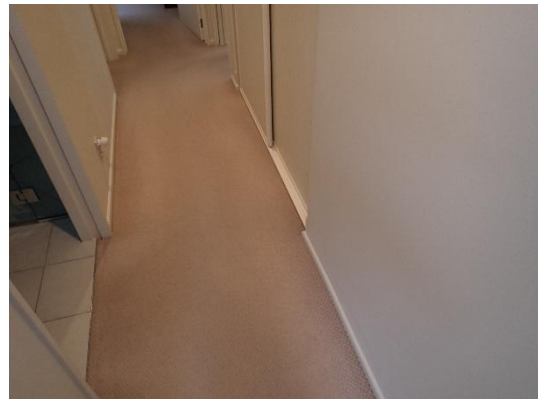
HALLWAY

No significant defects identified.

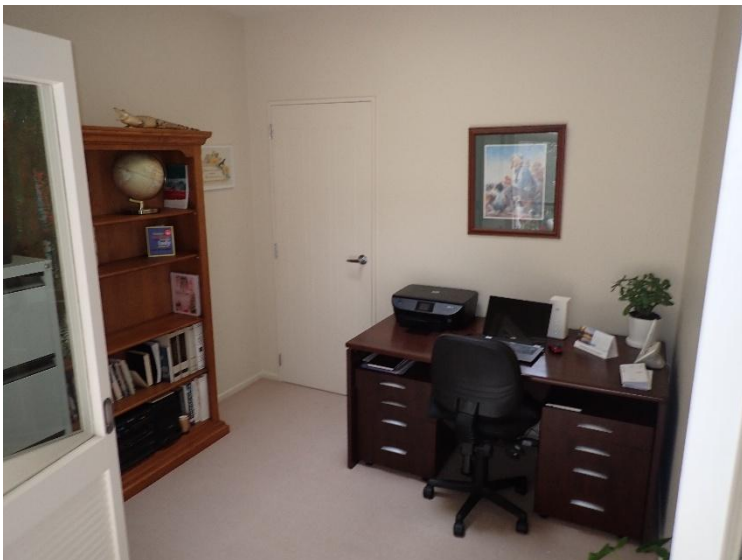
STUDY

No significant defects identified.

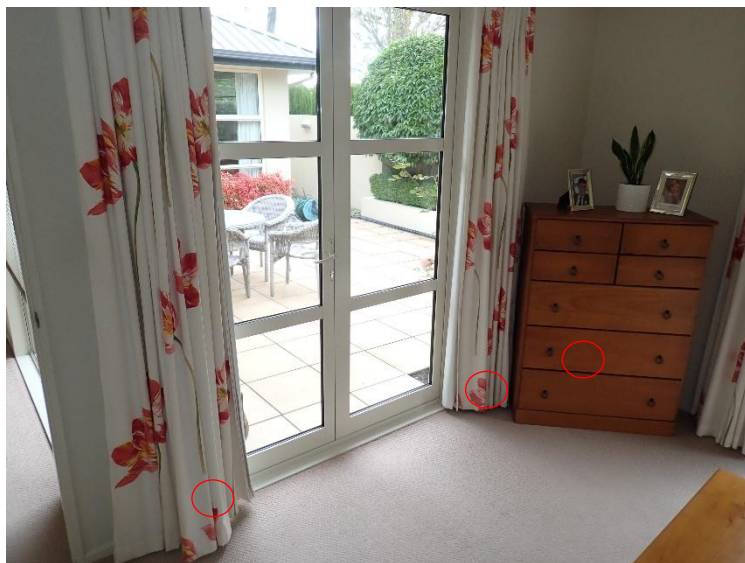
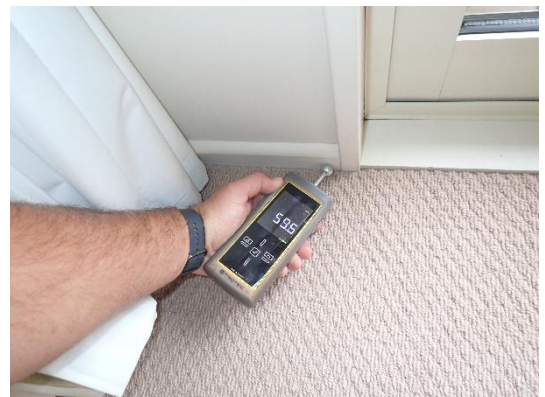
BEDROOM 1

Next to the study.

No significant defects identified.

Normal readings returned from moisture scanner.

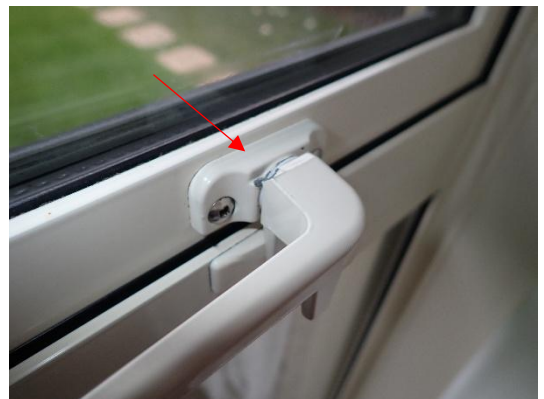
BEDROOM 2

There is damage to the window locks. This does not affect the function of the window however replacement could be considered.

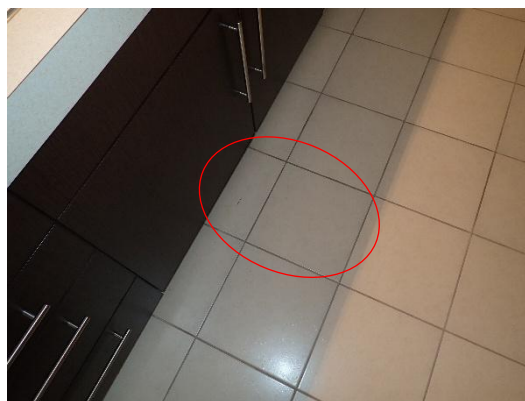
There are two cracked tiles in front of the sink.
Replacement could be considered.

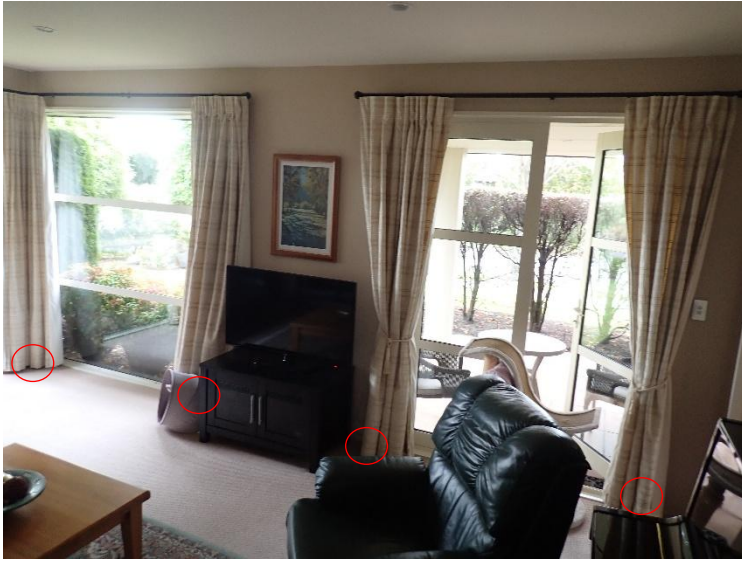
LOUNGE

No significant defects identified.

Normal readings returned from moisture scanner.

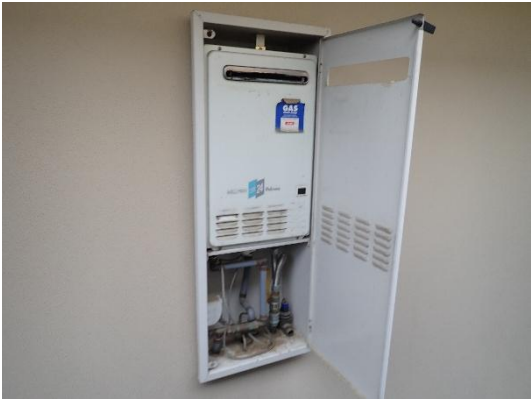
HOT WATER SUPPLY

Gas water heater.
On the south elevation.
No significant defects identified.

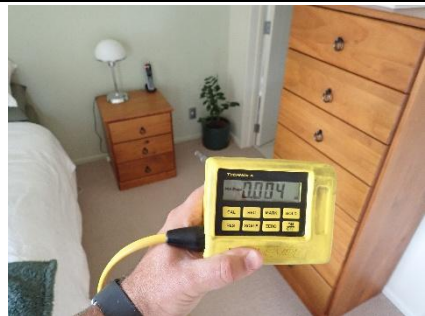
Description	Locations	Photographs
Overall Variation Across Floor (note: some displayed readings may not match the readings provided due to the adjustments made for differing floor covering thicknesses and steps in floor levels)	Lowest reading: Bedroom 1 (-4mm)

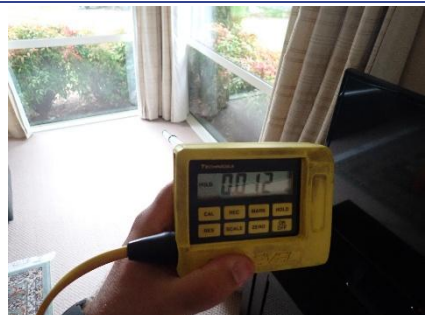
Highest reading: Lounge (+12mm)

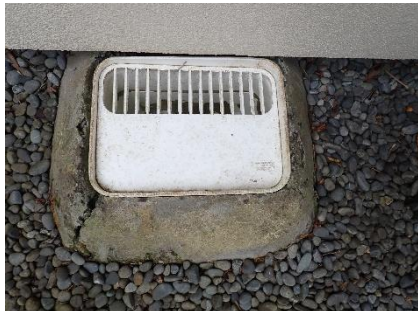
Comments	Photographs
Water Supply	Turned on. No significant faults identified.	
Gas Supply	The gas is provided by a reticulated gas supply that is located on the south elevation. No significant faults identified.	 
Drainage System	The wastewater system was tested by running water through to the gulley traps. The water appeared to drain freely through the wastewater system.

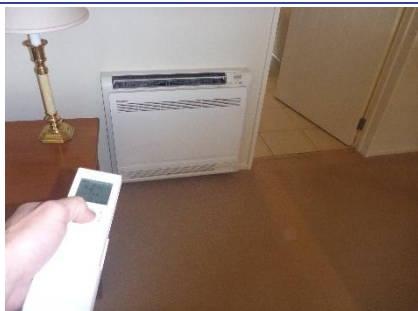
Stormwater System	There are no visual signs of stormwater blockages at the time of inspection.	 
Electrical Services	Turned on. No significant faults identified.	
Heating	Heat pump located in the family Room. No significant faults identified.

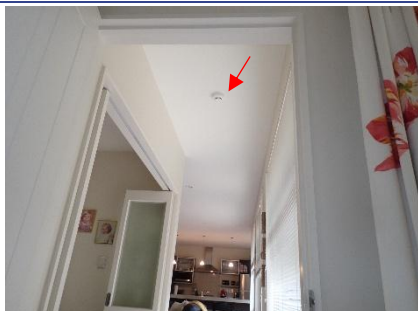
Smoke Detectors	Smoke detectors were located in the compliant locations.
